# Surveillance, maintenance and diagnosis of flood protection dikes

A practical handbook  
for owners and operators

Patrice Mériaux, Paul Royet

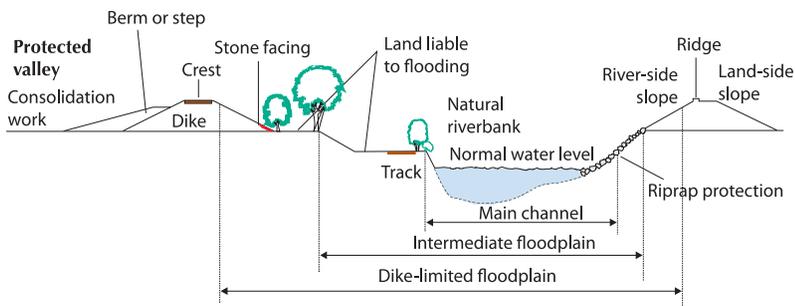
Figure 1. Typical cross-section of diked land

This handbook also contains a short list of terms specific to dikes (see Fig. 1 also), including explanations of abbreviations used in the book, as well as the basic principles of soil mechanics (Appendix 1) and soil hydraulics (Appendix 2). Finally, references to prices are given in euro (excluding taxes).

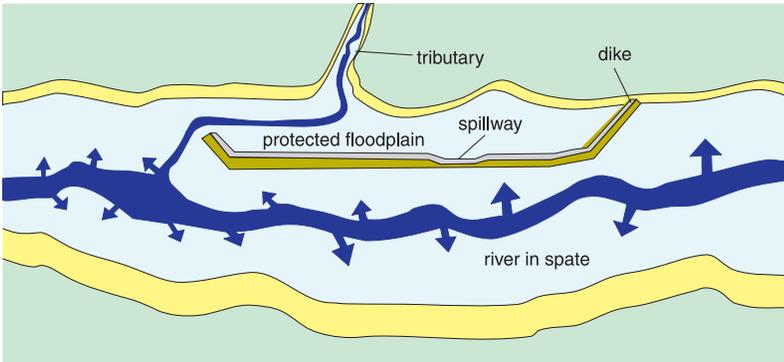
Figure 3a. Propagation of flood waters in a diked floodplain

- During a flood, rising water levels cause the river to break out of its main channel and spread over into the diked floodplain (Fig. 3a).

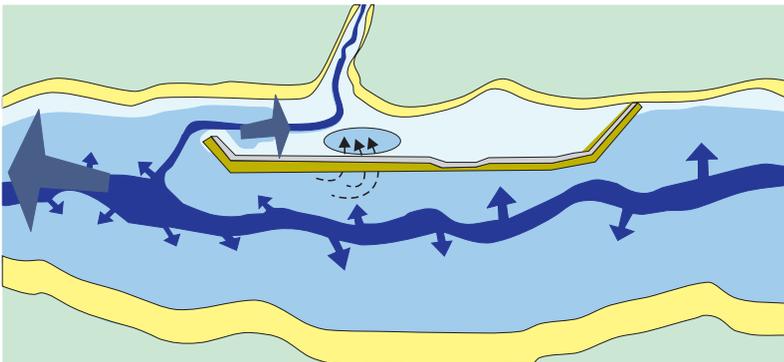
Figure 3b. Flooding of a valley by backing up, runoff from a catchment basin or a rise in the water table

- Flood peak reduction (which attenuates maximum discharge by propagation into parts of the floodplain) is thus limited during regular floods.
- Areas protected by dikes may, in certain cases, be flooded by main river water backing up into a tributary, by runoff from lateral catchment basins whose outlets into the river are saturated or by a rise in the water table (Fig. 3b).

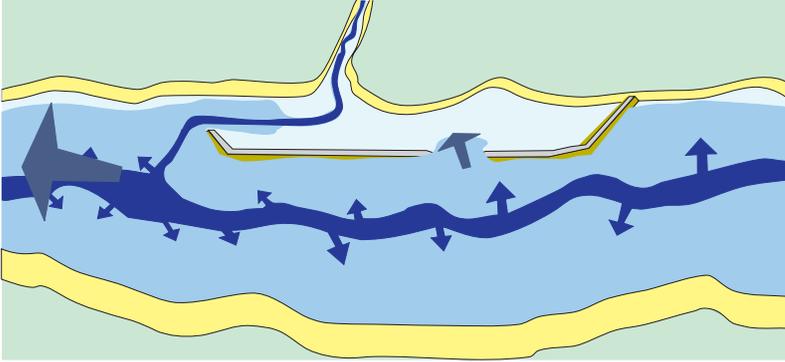
Figure 3c. Spillway operation

- To prevent overtopping (and the virtually certain failure) of dikes during a major flood, spillways are sometimes built into them which, when the water exceeds a certain level, make it possible to flood areas that are less built-up, giving flood waters more room to propagate and thus facilitate discharge (Fig. 3c). These deliberate flood propagation areas are sometimes themselves divided by embankments into a number of flood spreading plains that are inundated in turn.

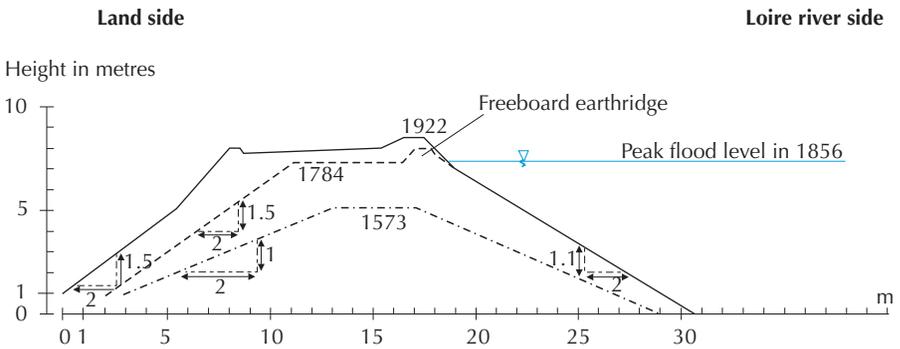
Figure 4. Typical cross-sections of River Loire levees before recent upgrading work

– Very often they were built in stages during different periods as the use of rivers and the need for defences changed (Fig. 4).

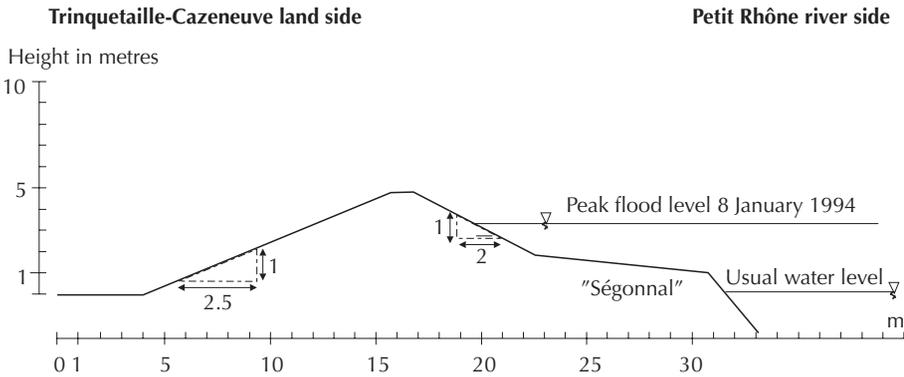
Figure 5. Typical cross-section of a dike on the Petit Rhône in the Camargue

The nature of earthfill materials may therefore vary widely, even along the same river (sandy in the middle reaches and silty nearer the mouth). Generally, however, single sections are of a homogeneous nature with no zoning and no special internal drainage system (Fig. 5).

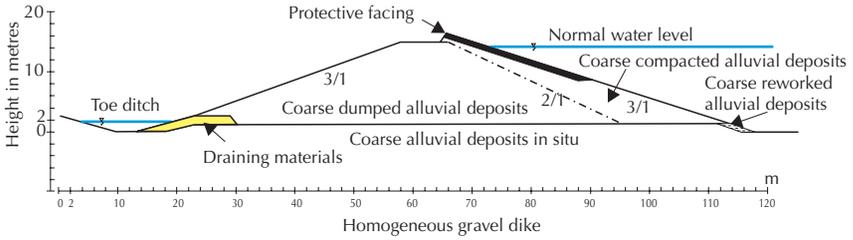
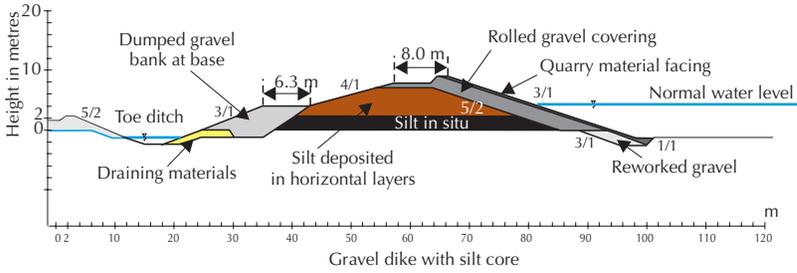
Figures 6. Typical cross-sections of Rhône dikes in the sector developed by the Compagnie Nationale du Rhône (CNR)

The most recent dikes use designs similar to those for dams, which integrate materials zoning and the separation of sealing and draining functions (Fig. 6).

To our knowledge, this technique was used in France on a CNR Rhône dike (*cf.* fig. 6) at the Péage-de-Roussillon site in 1996, after it had been weakened by the presence of rabbit warrens.

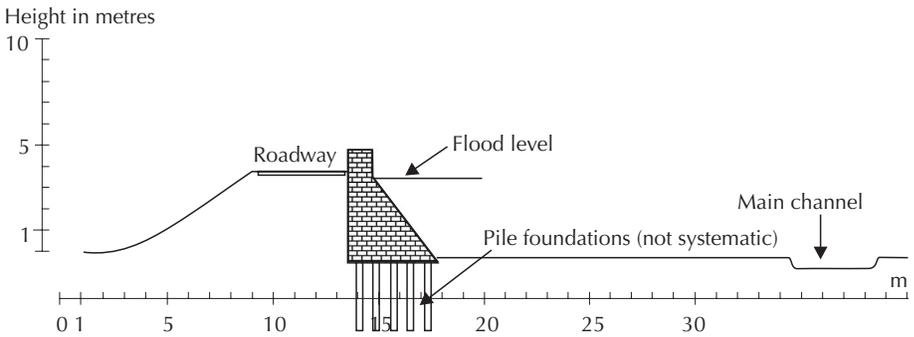
Figure 7. Typical cross-section of a masonry dike

These walls are characteristically steep on the river side and are often supported on the land side by an embankment, made of earth or coarse materials, which may also be topped by a road (Fig. 7). More recently, concrete has replaced stonework, although an external facing of stone is occasionally re-built to make a more attractive finish.

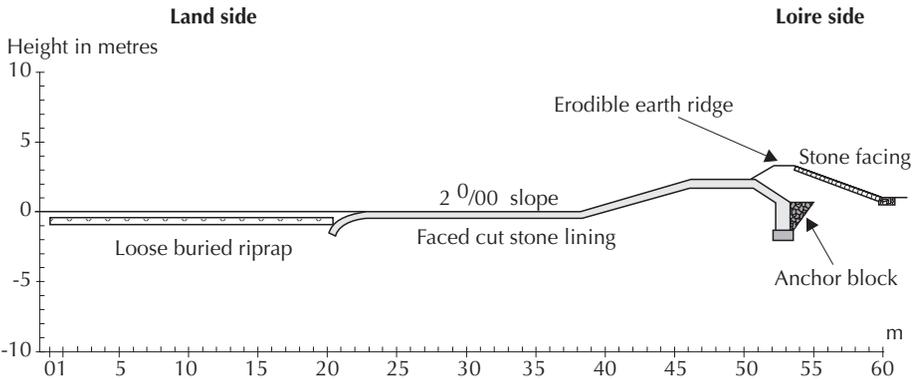
Figure 8. Typical cross-section of a “Comoy” spillway on the Loire river – (Ouzouer)

A masonry sill may sometimes be topped by an erodible earth ridge (earthfill fuse), lying slightly below the dike crest. This erodible fuse is designed to quickly wash out as overtopping begins, leaving a larger section free for flood routing (Fig. 8). This effectively delays the moment at which the spillway starts to function and valley flooding is less frequent.

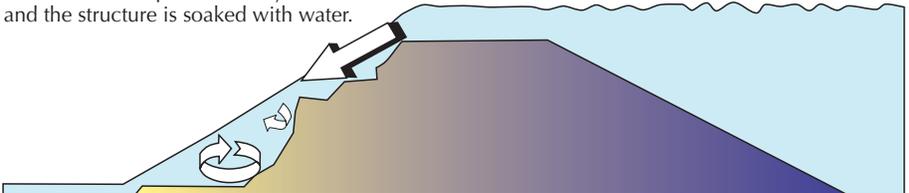
The dike facing is badly broken up, the toe of the slope is seriously undermined and the structure is soaked with water.

FIGURE 9. MECHANISM OF DIKE FAILURE CAUSED BY OVERTOPPING

Overtopping (when water rises above and flows over the crest of a dike) generally and rapidly<sup>1</sup> causes breaching (in the case of fill dikes), by retrogressive erosion of the land-side slope and then of the crest (Fig. 9). It is one of the principal (if not the principal) mechanisms identified in the failure of fill dikes, at least if we consider the major incidents that have affected French inland dikes during serious floods in the last two hundred years.

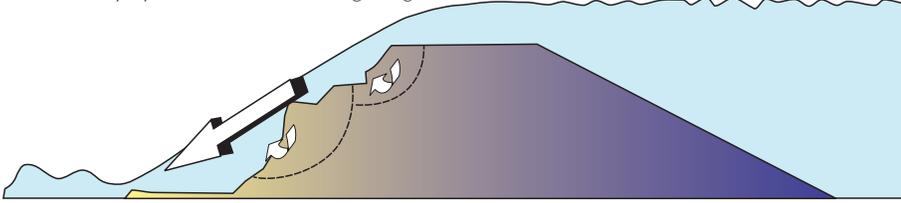
The waterlogged downstream facing is no longer stable and whole sheets of it slide downwards. Materials are quickly washed away by the current, which is getting faster.

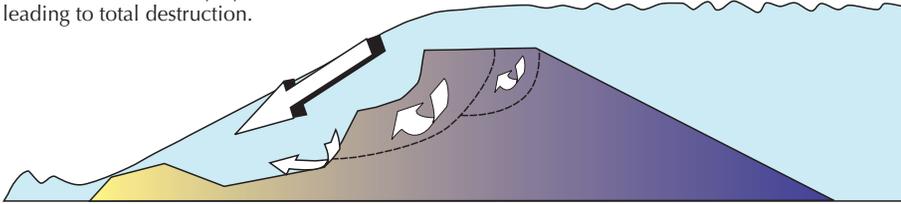
The process of disintegration accelerates, materials are torn away by the force of the current, leading to total destruction.

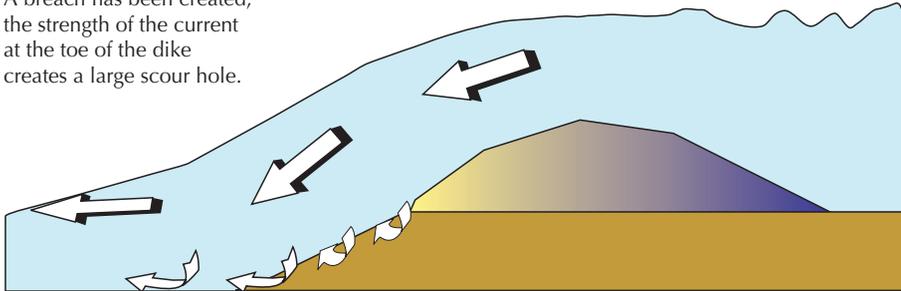
A breach has been created, the strength of the current at the toe of the dike creates a large scour hole.

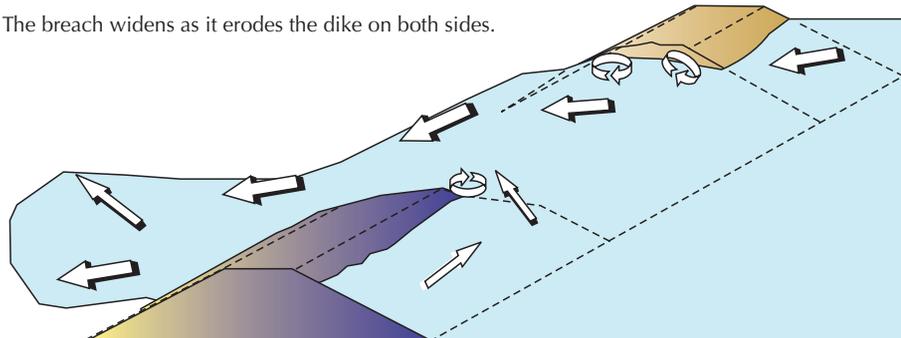
The breach widens as it erodes the dike on both sides.

FIGURE 9. (cont'd)

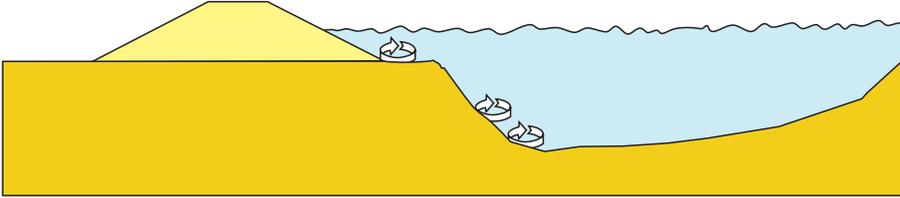
High velocity of flow and river-bank vulnerability are at the origin of erosion at the toe of the dike.

back up the slope, the result may be a breach in the dike itself. Overtopping will tend to speed up this phenomenon (see Fig. 10).

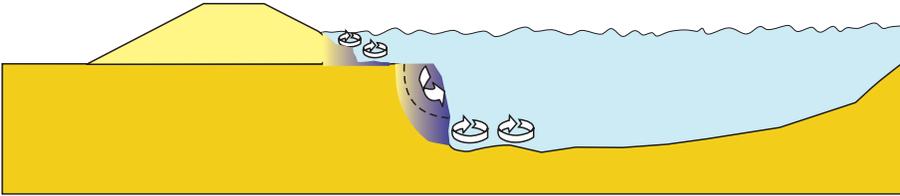
The toe of the bank deteriorates and saturated materials slide downwards.

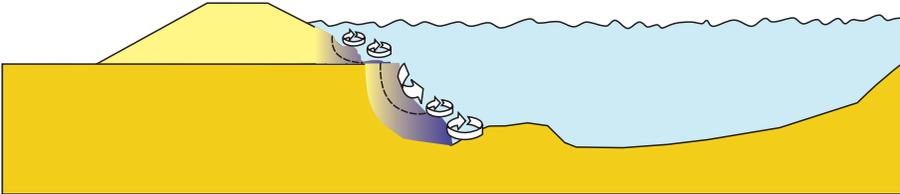
Repeated floods exacerbate the problem; the toe of the dike continues to break up.

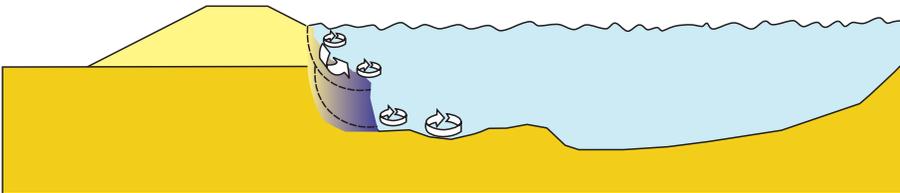
The bank, now vertical, is highly unstable. Whole sections of saturated materials slide down the slope, breaking up the dike as they go.

FIGURE 10. THE SCOURING PROCESS AT THE TOE OF A DIKE

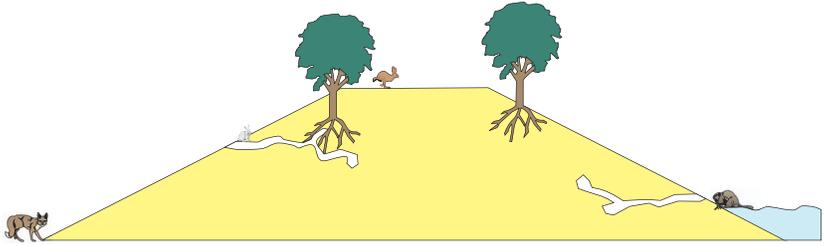
Animal burrows and warrens and the roots of trees form seepage paths that lead to piping.

gradient may locally reach a critical level, causing internal erosion and gradually creating a conduit along which gradient and velocity increase rapidly over time. If the phenomenon intensifies, the result may be a tunnel (or pipe) running across the dike or its foundations and, eventually, a breach due to caving-in (see Fig. 11).

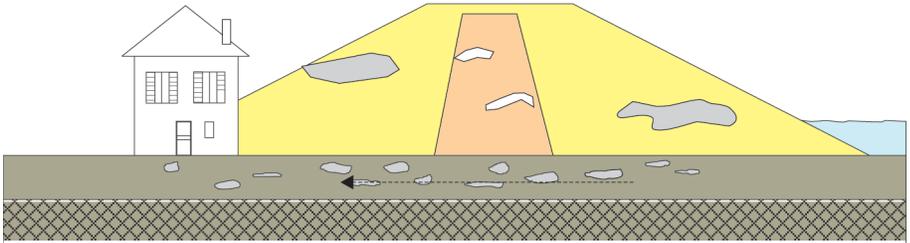
Embankment heterogeneity, pockets of sandy materials and embedded buildings, which facilitate internal movement of water by shortening the hydraulic path, may cause piping, as can pervious foundations.

FIGURE 11. (cont'd)

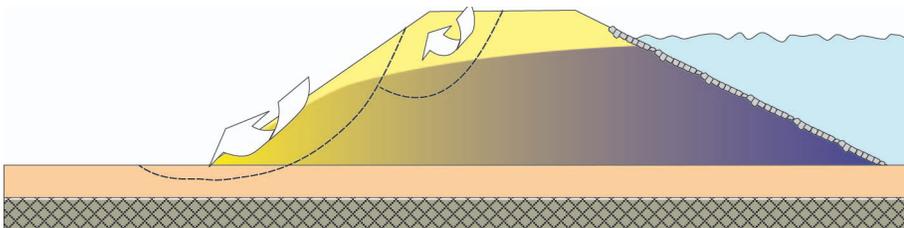
**A waterlogged embankment and a steep incline**  
 provoke extensive failure through landsliding

Figure 12.1. Failure mechanism on the downstream (land side) slope in a flood situation

However, we can consider that the risk of general instability under hydraulic load (in the form of instability on the land-side slope as illustrated in Fig. 12.1) does exist, particularly in the presence of three factors:

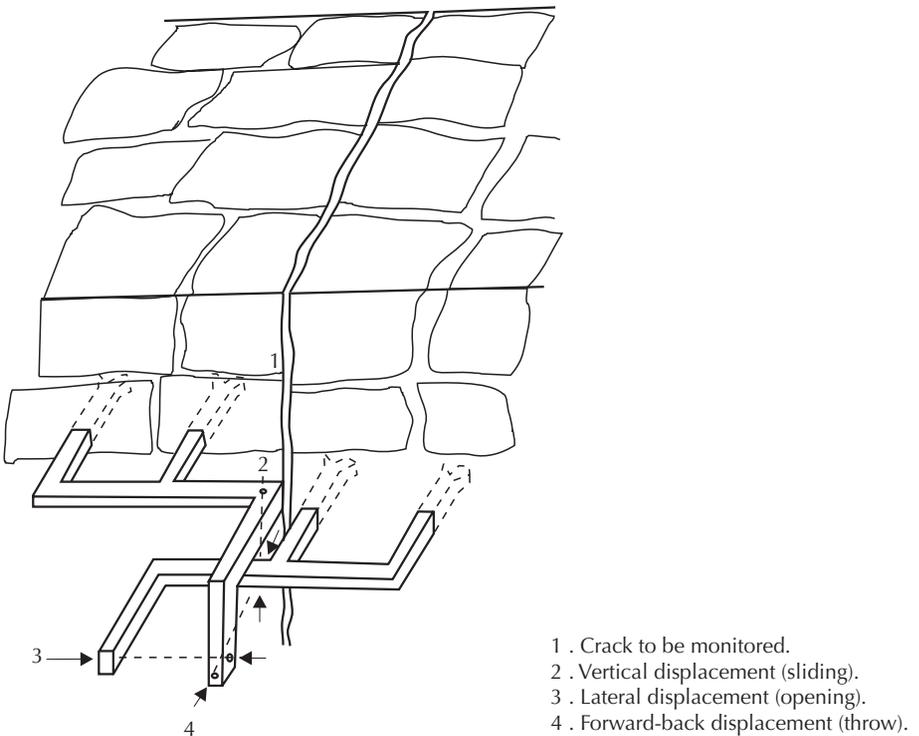
Figure 13 Movement around a crack and monitoring with a jointmeter

A three-dimensional jointmeter consists of two mating elbow-shaped brackets that are embedded into and straddle the crack. The cross-section of the metal brackets must be at least 2 cm x 2 cm. Displacement readings are obtained with a calliper gauge with an accuracy of 1/100 mm. The overall accuracy of the reading depends

Structural damage takes the form of cracks, which usually affect the entire structure across its width. They are due to differential settlements of foundations or to active earth pressure held back by the wall. They appear in three forms (Fig. 13) – opening, horizontal throw (relative forward-back displacement) and sliding (relative vertical displacement).

If such cracks or signs of displacement are noticed on a masonry or concrete wall, a civil engineering specialist should be called in to make a more accurate diagnosis so as to find the cause, evaluate the implications and recommend any necessary corrective measures. The specialist may suggest monitoring the crack using a simple fissurometer (allowing measurement in one direction only) or, preferably, a jointmeter, which measures relative displacement in three orthogonal directions (Fig. 13).

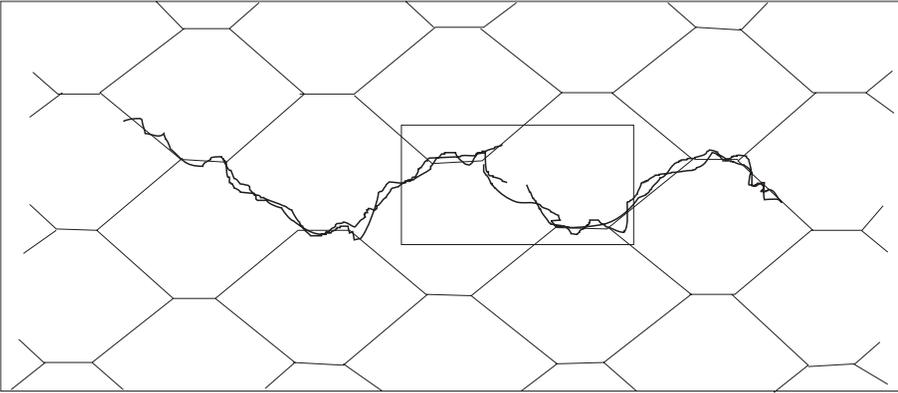
Figure 14. Repair of broken wire on a gabion cage

- A localised break is often caused by a sudden impact or bending that has led to chipping of the galvanised wire. If attended to rapidly, repair is simple, a new section of galvanised wire being introduced as shown in Fig. 14.
- Extensive corrosion may appear in areas where the water level fluctuates, producing whole lines of broken wire, with the result that the contents of the cage spill out. Repairs should be carried out as soon as generalised corrosion is noticed and, in any event, before multiple breaks set in. The corroded netting should be covered with a new section of galvanised netting, which needs to be firmly fixed all the way around. If necessary, a mortar facing can be added to areas especially exposed to corrosion.

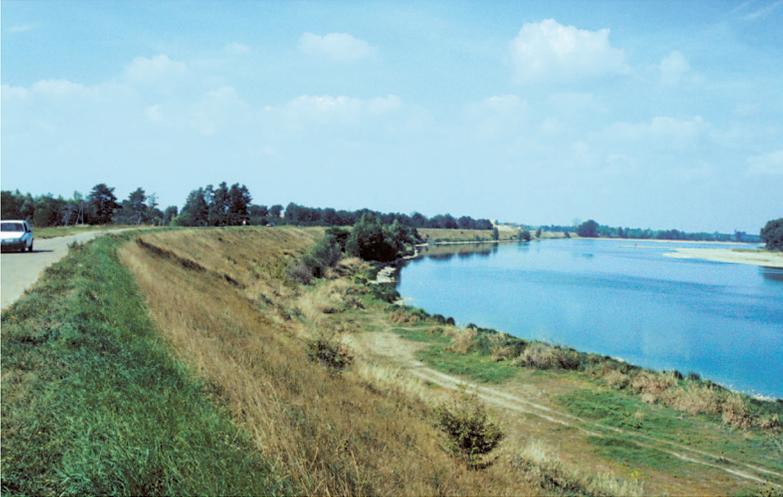
Photo 1.1 – Typical view of a levee on the middle reaches of the Loire: fill dike with a broad cross-section, grassed slopes and crest roadway.

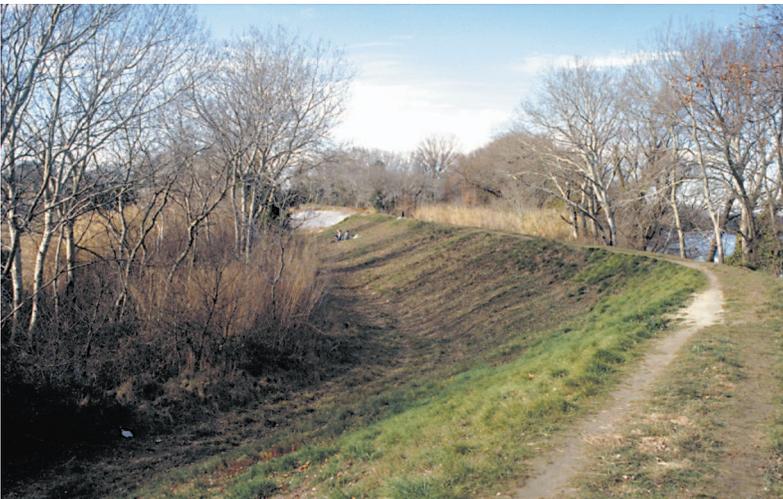
Photo 1.2 – Fill dike on the Petit Rhône in the Camargue (Bouches-du-Rhône), prior to upgrading work in 1994. Its crest is too narrow to allow plant and machinery to pass.

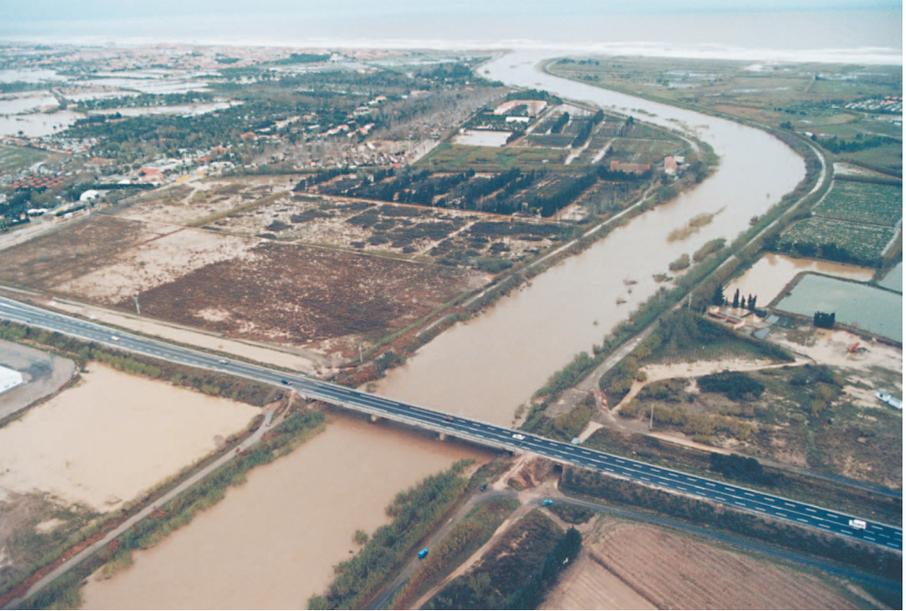
Photo 1.3 (courtesy of Frédéric Hédelin) – Aerial view of the diked downstream section of the Agly coastal river (Pyrénées Orientales), just after flooding on 12-13 November 1999.

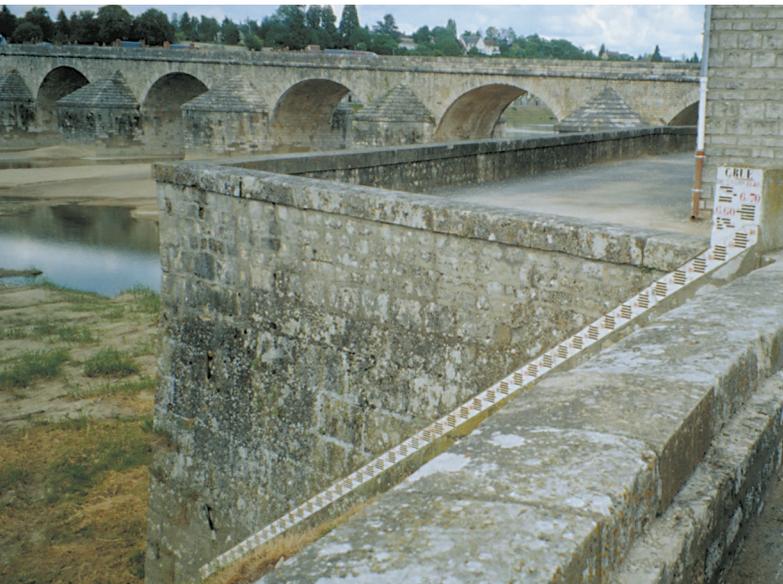
Photo 1.4 – Stonework quay wall on the left bank of the Loire in Gien (Loiret), showing water level indicator and record flood levels.

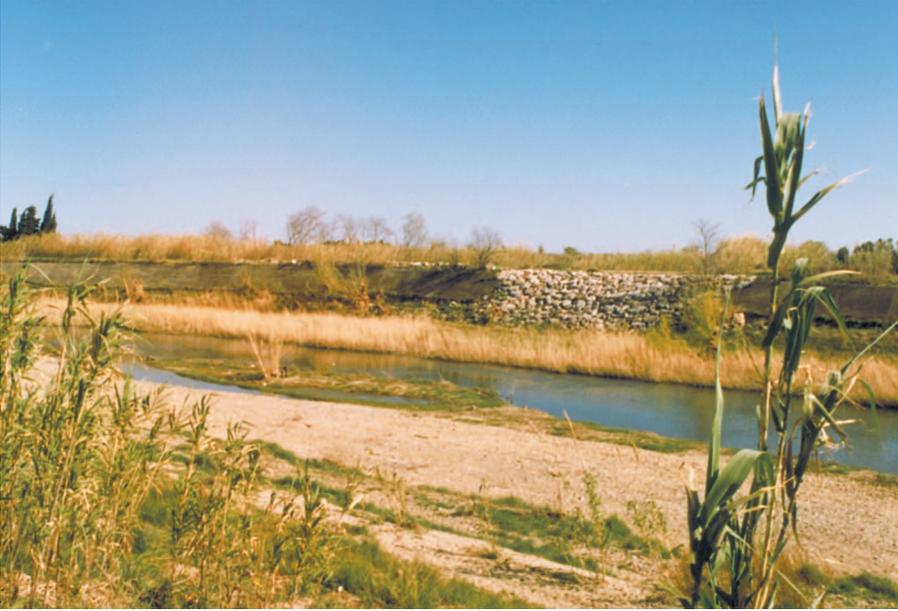
Photo 1.5 – Old concrete protection on the bank and river-side slope of the Agly right-bank dike (Pyrénées Orientales). Recent repairs have been made in riprap.

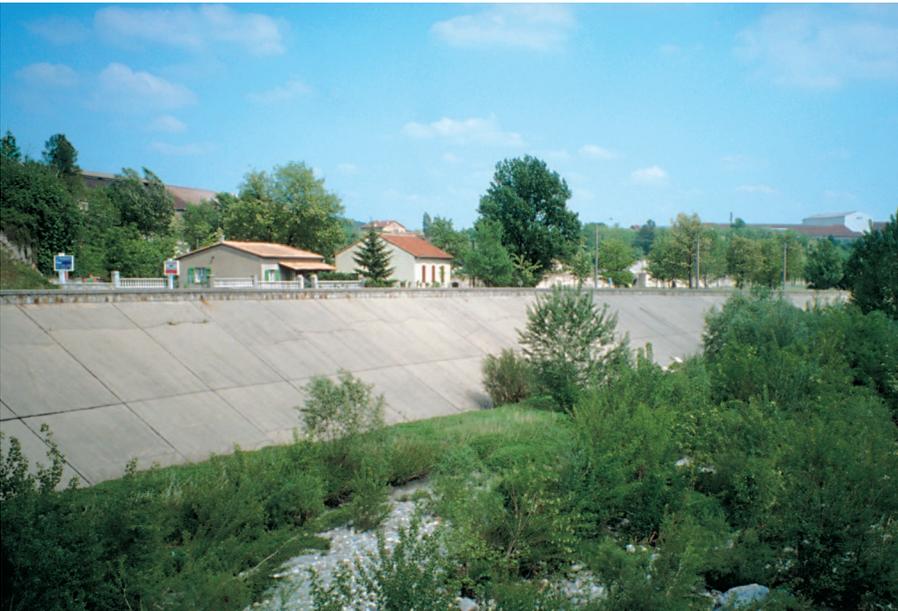
Photo 1.6 – Work dating from 1958 on the Gardon river as it passes through the town of Alès (Gard): the bank is protected by concrete slabs that only locally serve as a dike.

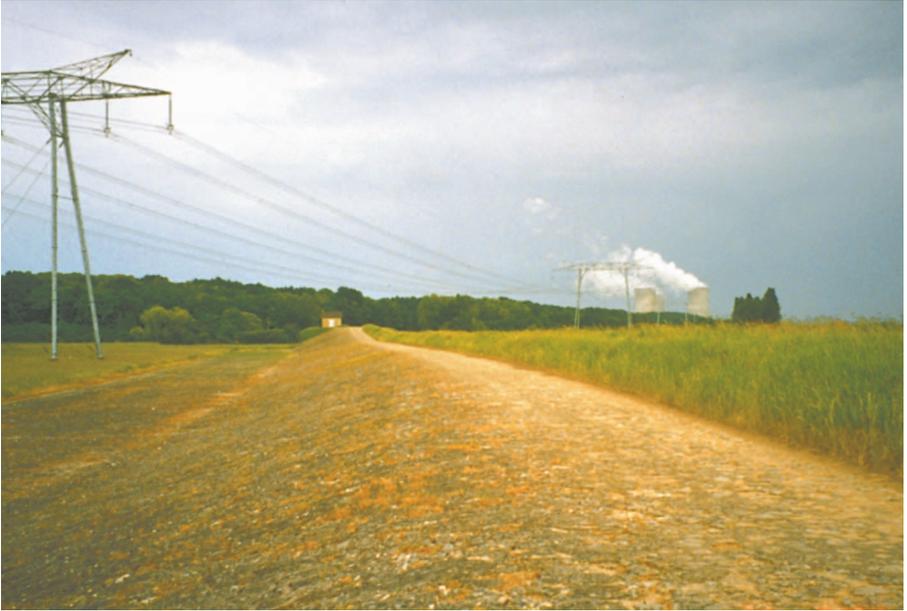
Photo 1.7 – Masonry spillway at Ouzouer-sur-Loire (Loiret), with erodible earth ridge (grassed bank on the right of the photo) called “banquette” in France.

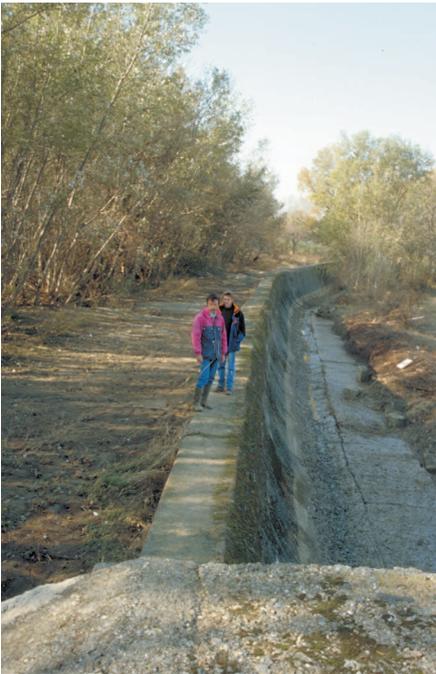
Photo 1.8 – Concrete spillway on the left-bank dike of the River Aude in Cuxac-d’Aude.

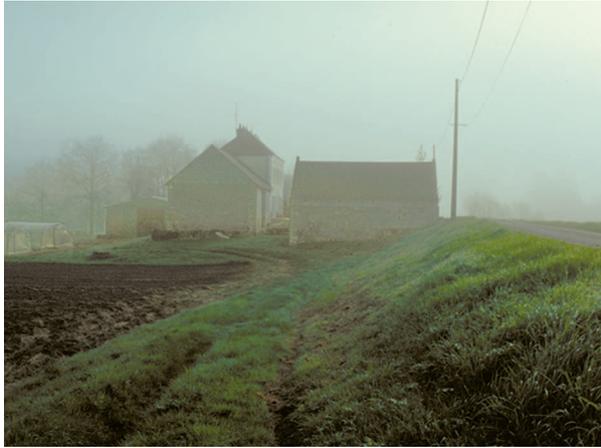
Photo 1.9 – Construction embedded in the land-side slope of a River Cher levee at Savonnières (Indre-et-Loire).

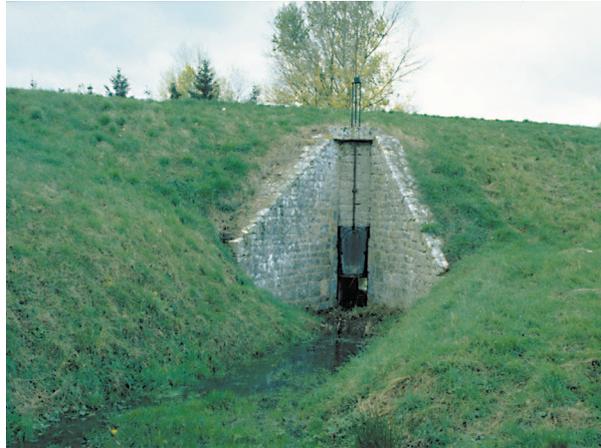
Photo 1.10 – Closable sluice in a Loire levee at Val de Bou (Loiret), seen from the land side.

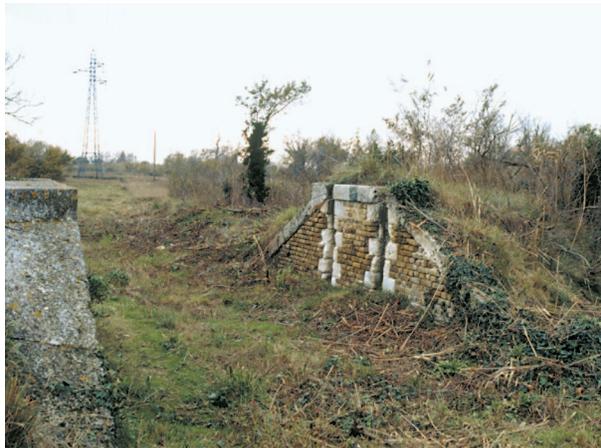
Photo 1.11 – Closable track on the right-bank dike of the Grand Rhône at Salins-de-Giraud (Bouches-du-Rhône).

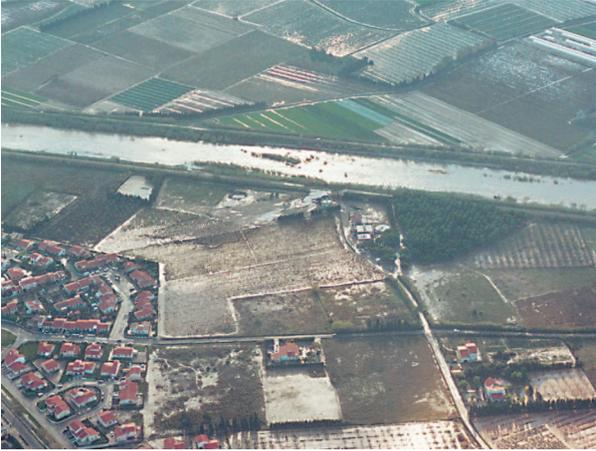
Photo 2.1 (courtesy of Frédéric Hédelin) – Aerial view of a breach caused by overtopping at St-Laurent-de-la-Salanque on the left-bank dike of the Agly, following flooding on 12-13 November 1999. The breach unfortunately appeared next to the waste-water treatment plant. Fortunately, the residents had been evacuated.

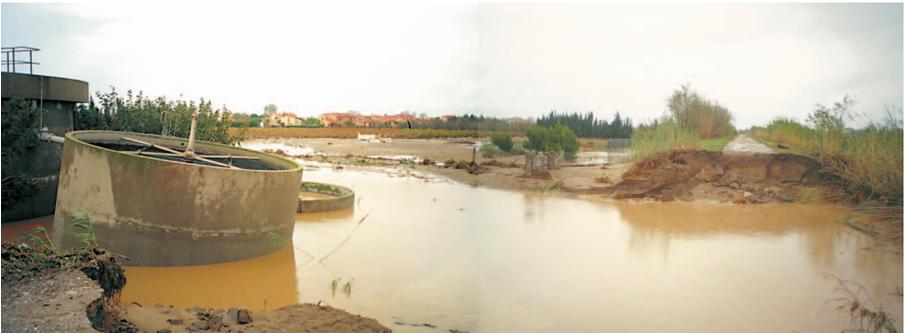
Photo 2.2 – Panoramic view (courtesy of Éric JOSSE, DDE 66) – Cross-section of the breach caused by overtopping at St-Laurent-de-la-Salanque on the left-bank dike of the Agly and damage to the waste-water treatment plant.

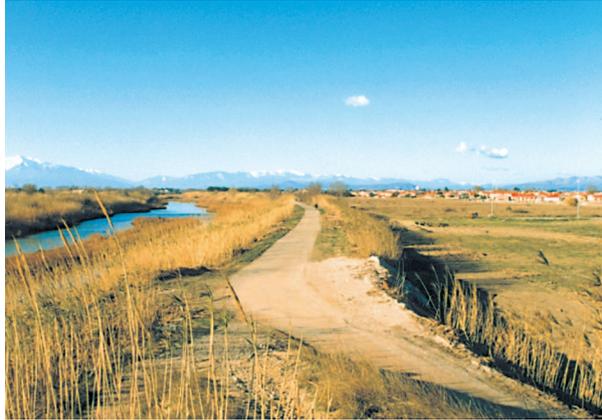
Photo 2.3 – Localised area of repaired overtopping on the land side of the left-bank dike of the Agly at St-Laurent-de-la-Salanque, following damage caused by flooding on 12-13 November 1999.

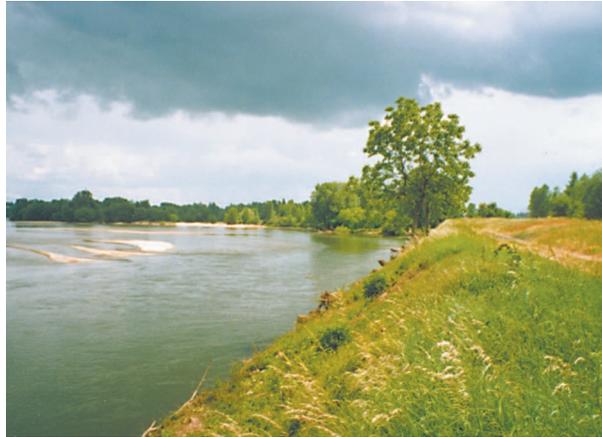
Photo 2.4 – Toe of a dike in contact with the main channel of the Loire on a concave bend of the Espagne levee at La Charité-sur-Loire (Nièvre).

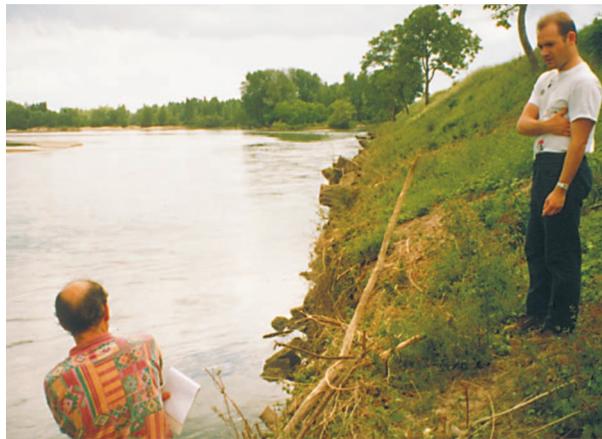
Photo 2.5 – Foot of a scoured bank at the base of the Espagne levee at La Charité-sur-Loire.

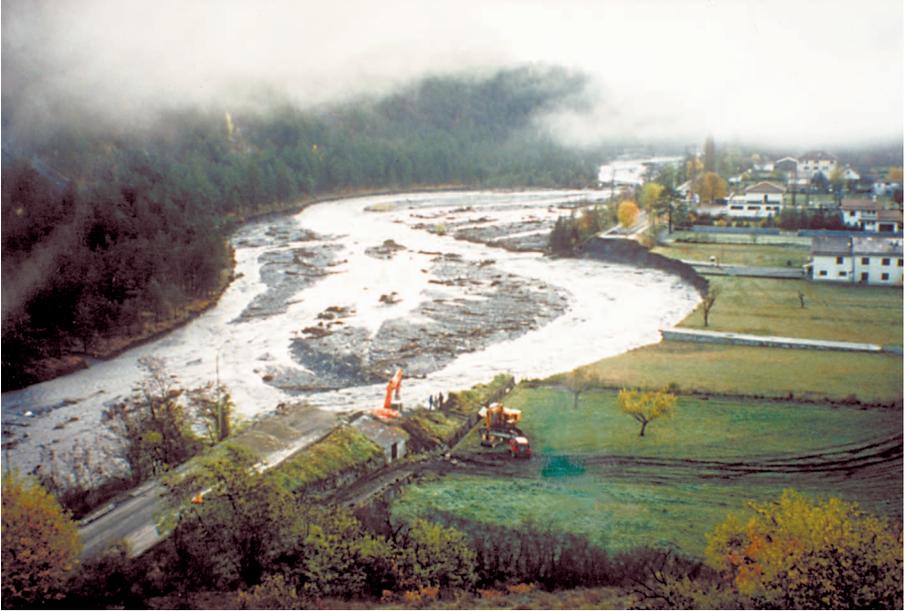
Photo 2.6 (Source: ONF Alpes Maritimes) – Eroded bend caused by flooding of the River Var on 5 November 1994: the Guillaumes dike (Alpes Maritimes) with over 150 metres of the D2202 roadway swept away.

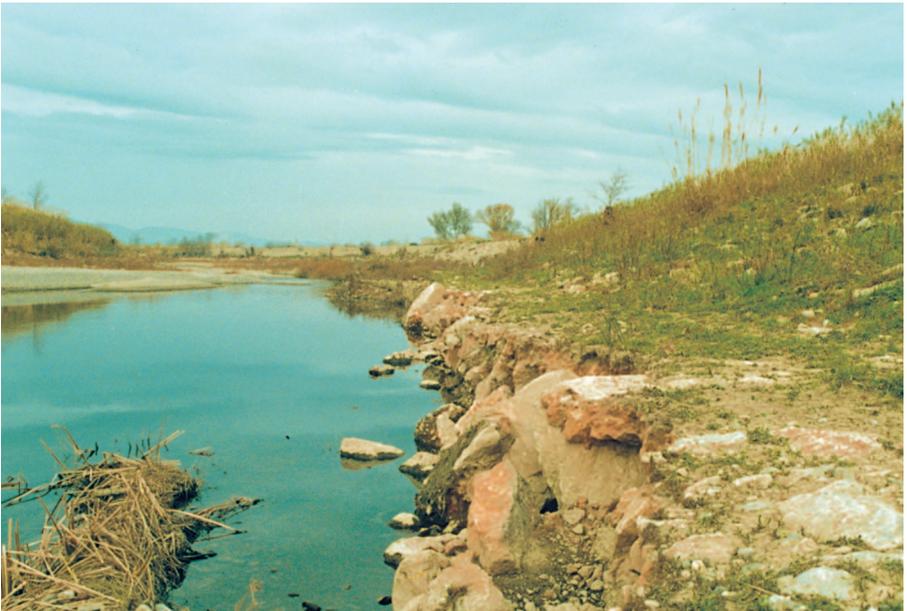
Photo 2.7 – River Agly dikes: foundation anchor block made of rip-rap at the foot of a bank partially swept away during flooding on 12-13 November 1999.

*Foundation anchor block*: Riprap abutment at the toe of a protective facing on the river-side slope of a dike.

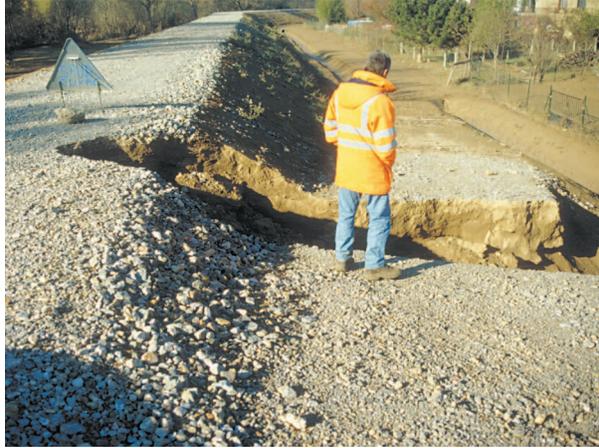
Photo 2.8 (Cemagref: Cyril Folton)  
– Damage caused by tunnel erosion (piping) in the new dike at Cuxac-d'Aude during flooding on 12-13 November 1999. A badly-installed conduit crossing was found to be the cause.

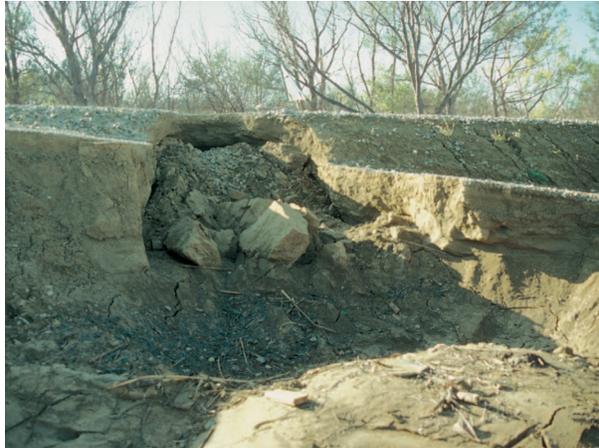
Photo 2.9 (Cemagref: Cyril Folton)  
– Downstream (land side) outlet of the piping.

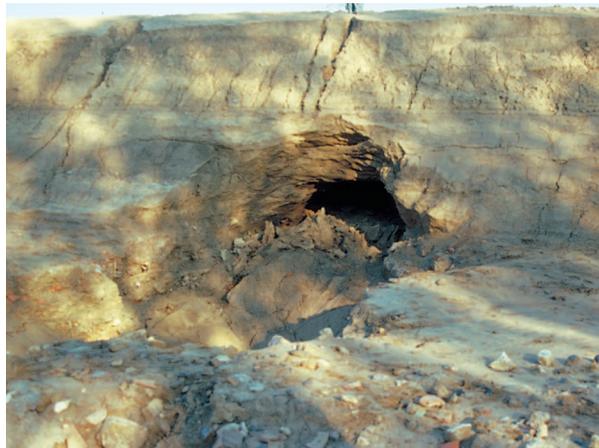
Photo 2.10 (Cemagref: Cyril Folton)  
– Upstream (river side) outlet of the piping. Water was able to flow through the dike at a rate of several hundred litres per second. Breaching was only narrowly avoided.

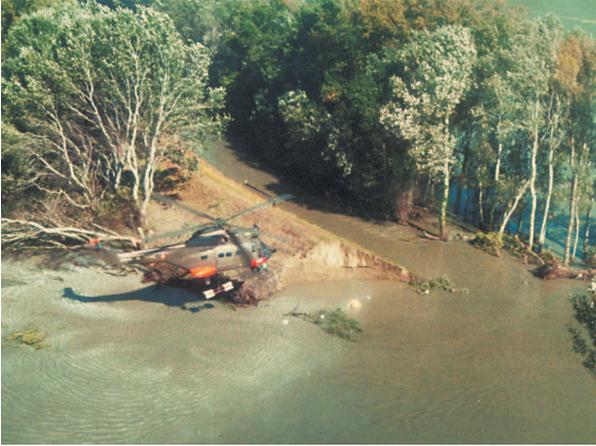
Photo 2.11 (Source: Service Navigation Rhône-Saône) – Internal erosion (animal burrows or warrens, conduit crossings) was found to have caused all 16 breaches in the Camargue dikes during the two Rhône floods in the winter of 1993-1994.

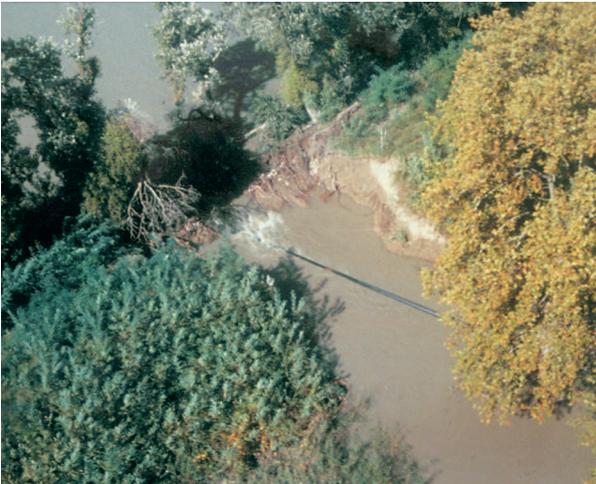
Photo 2.12 (Source: Service Navigation Rhône-Saône) – Aerial view of a Camargue dike breach that coincides with a pipe crossing.

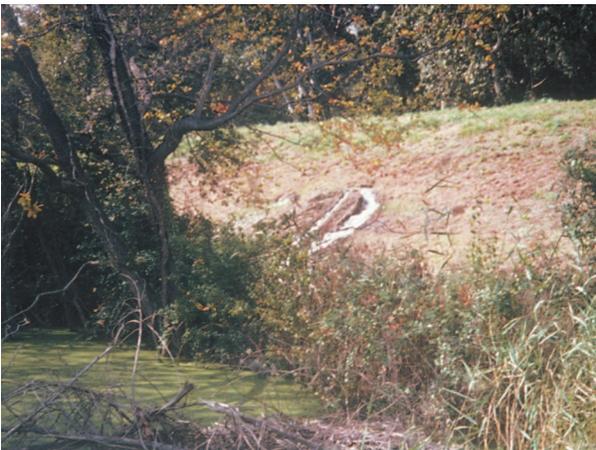
Photo 2.13 (Source: Service Navigation Rhône-Saône) – Leak on the downstream face of a Camargue dike caused by animal burrowing.

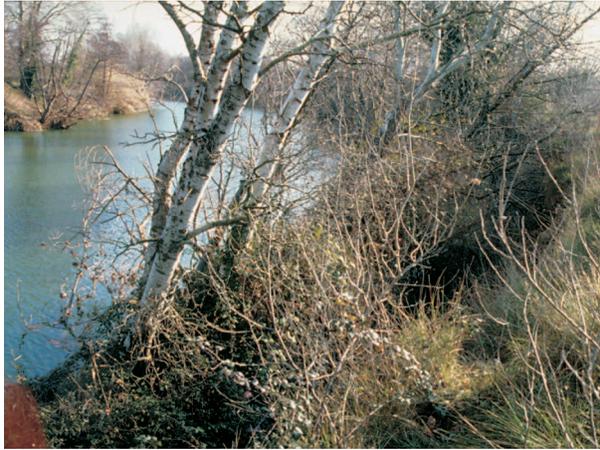
Photo 2.14 – Evidence of soil creep on a dike along the River Vidourle (Hérault). Notice the angle of the trees.

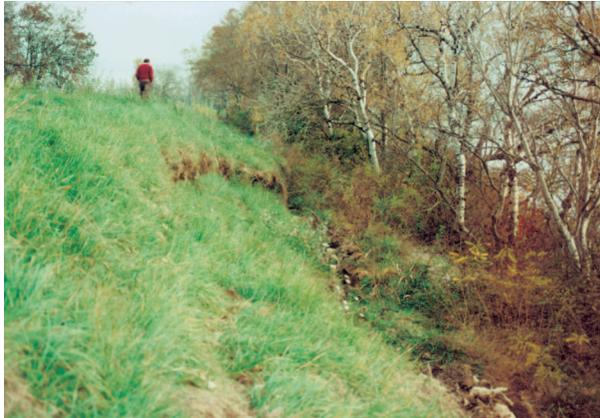
Photo 2.15 (Source: DDE 13) – Landslide following the retreat of flood waters – river-side slope of the left-bank dike of the Grand Rhône at Mas de la Ville.

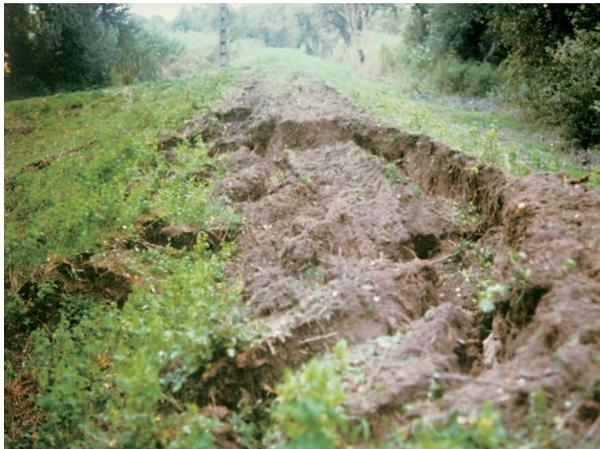
Photo 2.16 (Source: DDE 13) – Embankment landslide affecting the crest of the structure (Camargue dike).

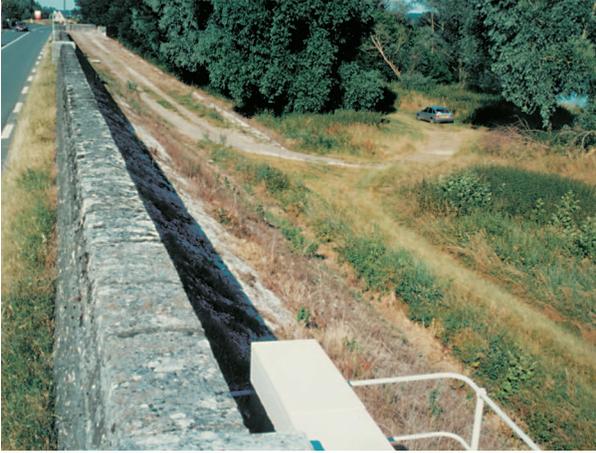
Photo 2.17 (Cemagref, Rémy Tourment) – Freeboard masonry wall on the river-side crest edge of the Val de Cisse levee (Indre-et-Loire). Access to the river in the background.

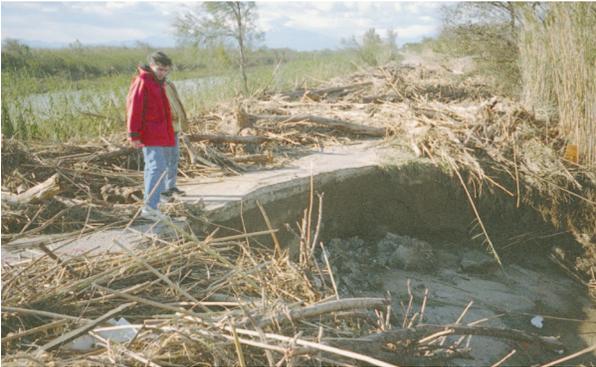
Photo 3.1a (Source: DDE 66) – Damage caused by overtopping on the River Agly dikes following flooding on 12-13 November 1999. Extensive eroded zone in the embankment and high-water debris left on the crest.

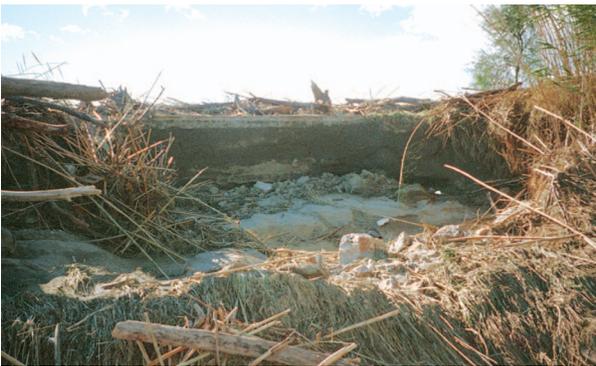
Photo 3.1b (Source: DDE 66) – Detail of the eroded zone shown in the previous photo, revealing layers in the dike composition.

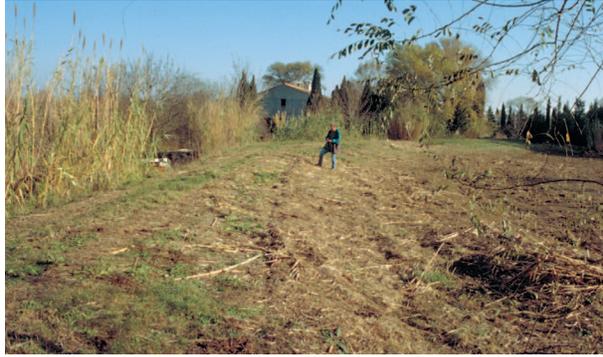
Photo 3.2 – Line of debris left by retreating flood waters on the river-side slope of the Cuxac-d'Aude dike after flooding on 12-13 November 1999.

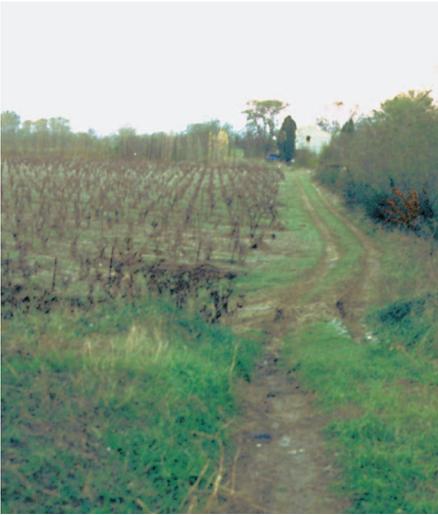
Photo 3.3 – Post-flood inspection of the Cuxac-d'Aude dike: low points on the crest (passage of pathway) where overtopping occurred.

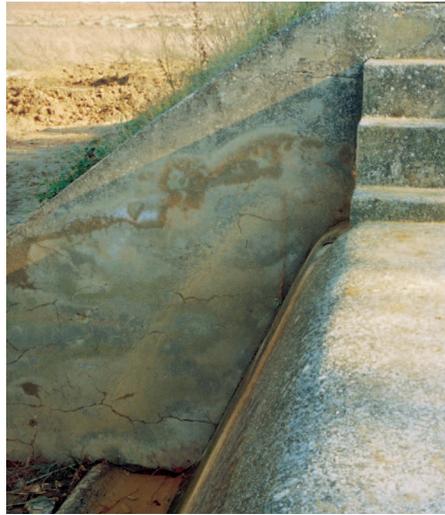
Photo 3.4 – Spillways need to be carefully inspected after flooding. Here, muddy traces left on the side wall make it possible to estimate the peak spillover height.

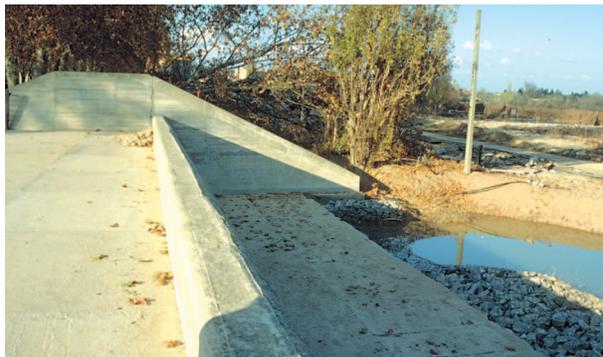
Photo 3.5 – Spillway at Sallèles d'Aude after flooding on 12-13 November 1999, showing damage to the gabion-built protective invert.

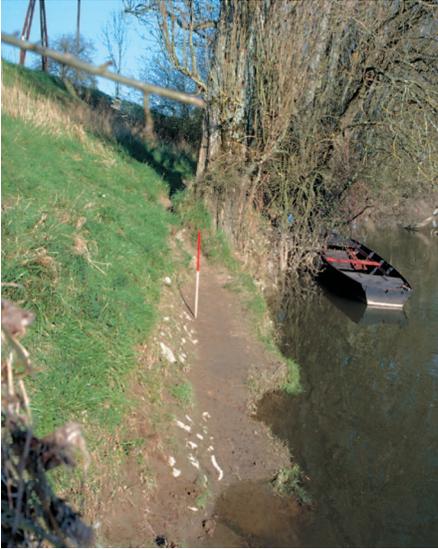
Photo 3.6 – When old stone facing is exposed at the base of a river-side flood embankment, it may indicate undermining by the watercourse.

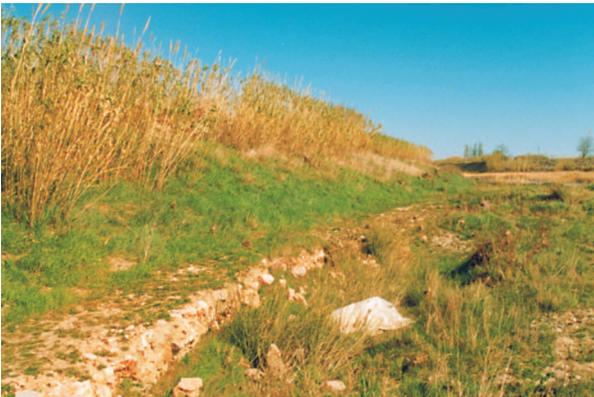
Photo 3.7 – River Agly dike inspection following flooding on 12-13 November 1999: exposed foundation anchor block made of rip rap, at the foot of a bank.

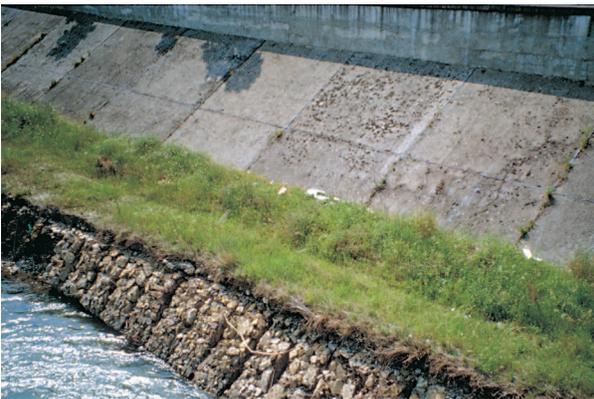
Photo 3.8 – Scouring at the foot of a protected bank on the Gardon d'Alès – gabion protection in poor condition.

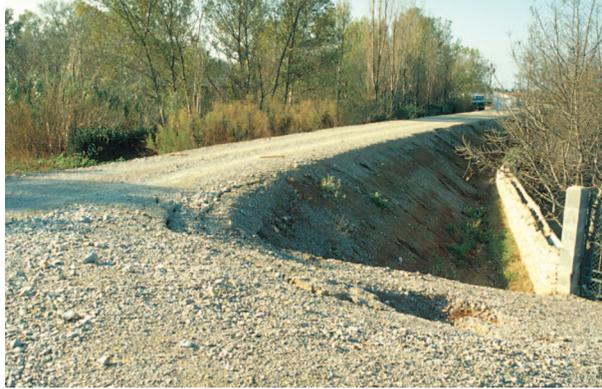
Photo 3.9 – Sink hole and collapsed areas on the land-side top of the dike at Cuxac d'Aude after flooding on 12-13 November 1999. A conduit crossing was the cause of the damage.

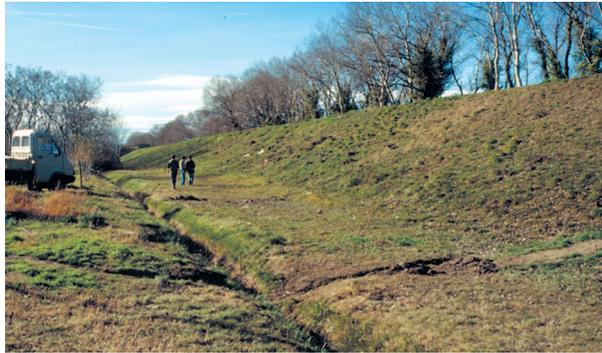
Photo 3.10 – Inspection of the Petit Rhône dike near Arles after flooding on 8 January 1994: evidence of seepage across the embankment at the toe of the land-side slope.

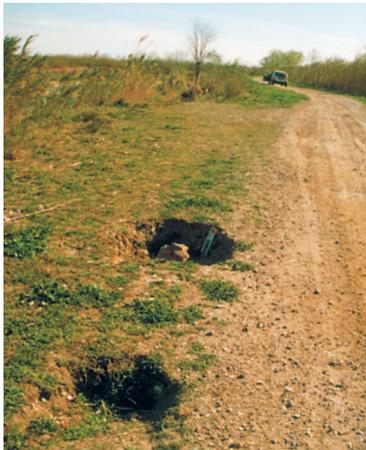
Photo 3.11 – Sink holes along a dike crest are often a sign of internal erosion. Here, two sink holes appeared in the Agly dike crest within a few weeks of each other after the flood of 12-13 November 1999.

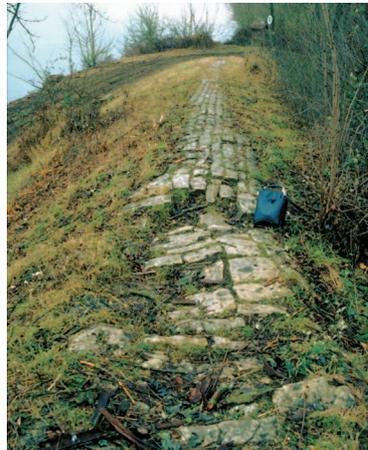
Photo 3.12 – Collapsed area on a masonry crest on a River Allier dike at Moulins (Allier), indicating internal erosion and/or settling of earthfill materials.
