# Surveillance, maintenance and diagnosis of flood protection dikes

A practical handbook  
for owners and operators

Patrice Mériaux, Paul Royet

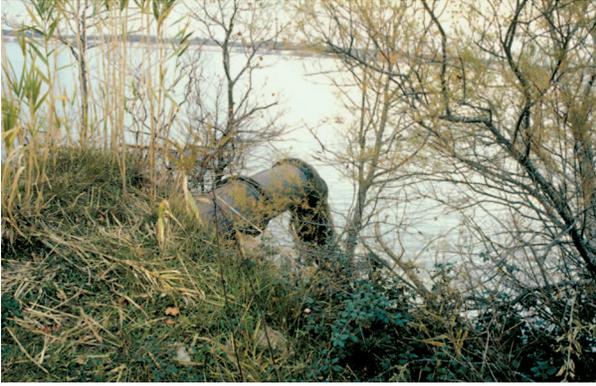
Photo 3.13 – The passage of pipes through embankments (here, a pumping station conduit drawing water from the Grand-Rhône) are points to be given particular attention during inspections.

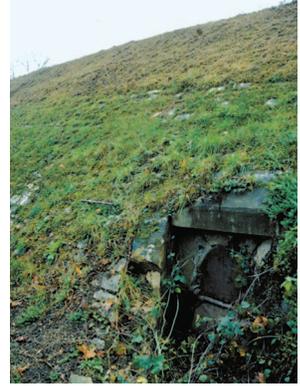
Photo 3.14 – A non-return valve outlet at the toe of the river-side slope of a dike on the River Allier at Moulins.

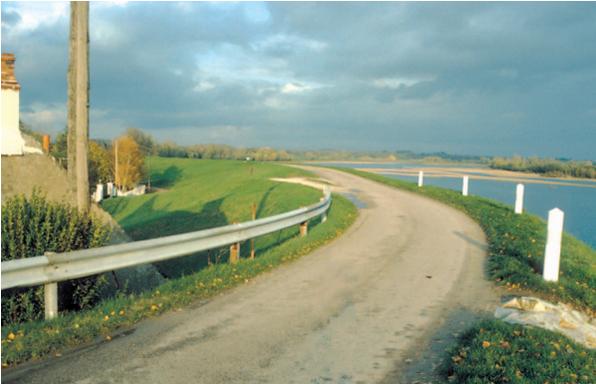
Photo 3.15 – Section of the Val de Bou levee on the right bank of the River Loire, made narrower because of the presence of a house on the land side: a potentially vulnerable spot to be inspected during flooding.

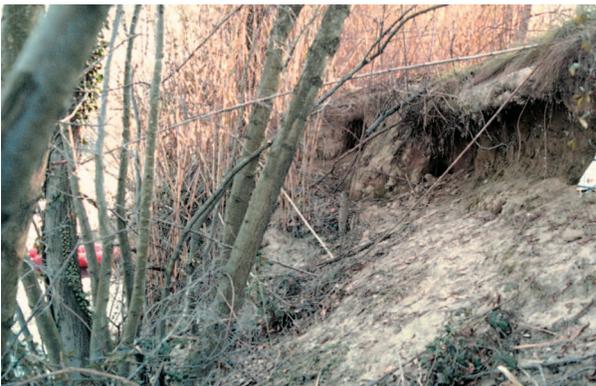
Photo 3.16 – Escarpment and leaning trees on a river bank or on the river-side slope of a dike indicate general slope instability following the retreat of flood waters.

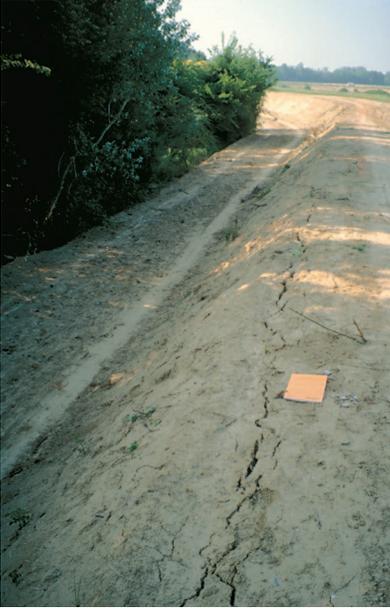
Photo 3.17 – Slopes with a gradient that is too steep (river side in this case) expose the dike to the risk of instability.

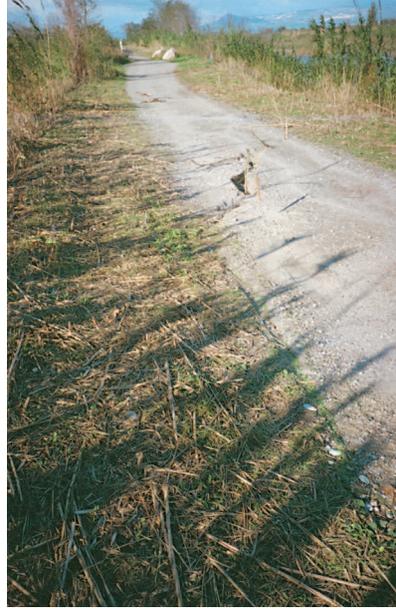
Photo 3.18 – Crack formation on the crest of a dike following the retreat of River Agly flood waters in November 1999 – sign of river-side slope instability following a rapid fall in the river water level.

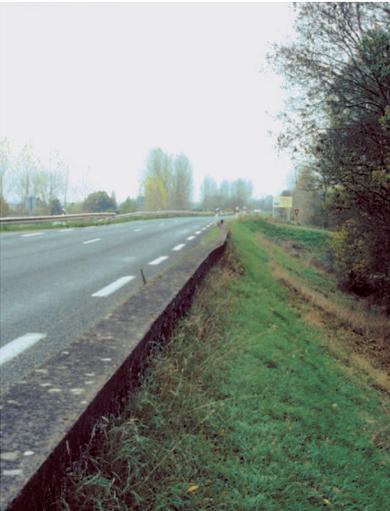
Photo 3.19 – Unstable freeboard masonry wall on the Authion valley levee (Maine-et-Loire)

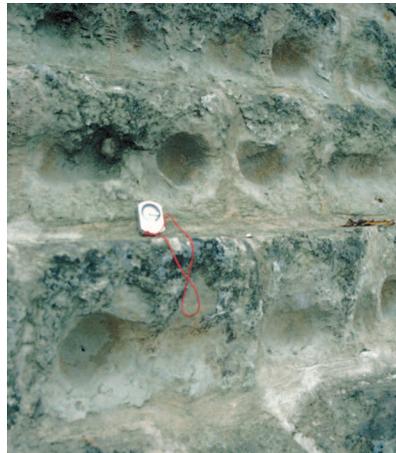
Photo 3.20 – Dressed freestone (frequently used in the Loire valley) is subject to dissolution.

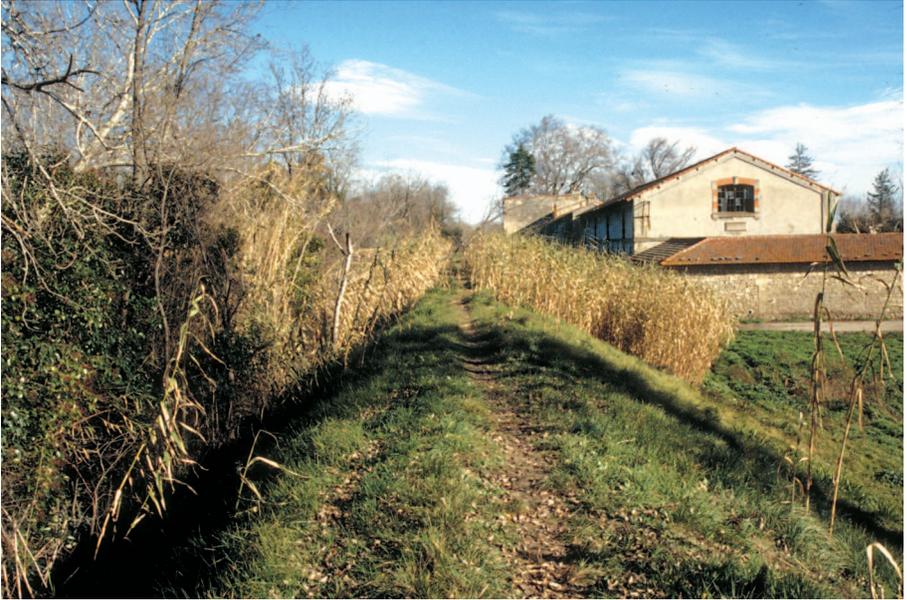
Photo 5.1 – Dense ground cover (in this case, giant reeds) makes it very difficult to visually inspect this dike on the Petit-Rhône.

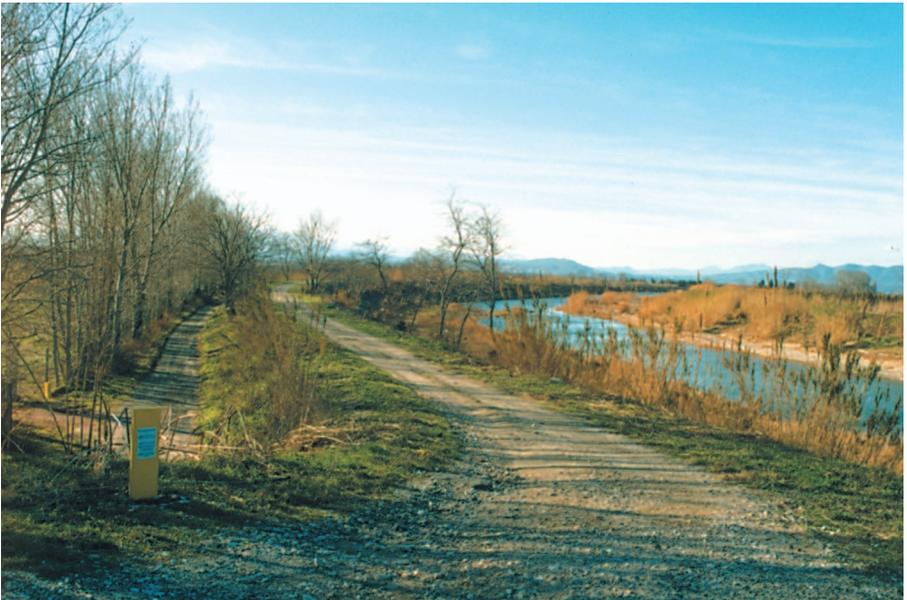
Photo 5.2 – Service tracks along dike crests (and in this case along the land-side toe of the embankment) facilitate surveillance operations on the River Agly.

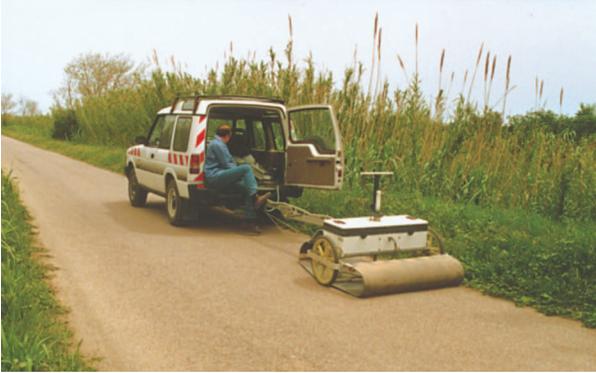
Photo 6.1 – Geophysical exploration using the radio magnetotelluric (RMT) method on the top of the Agly dike.

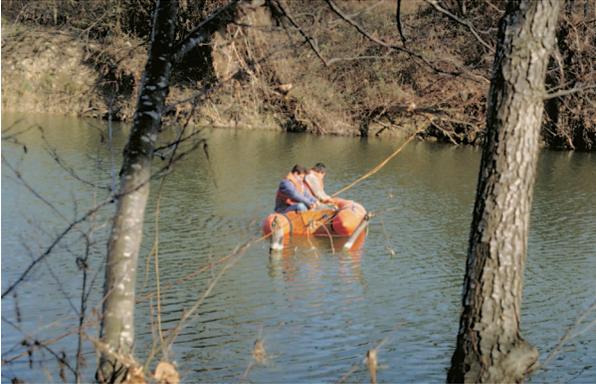
Photo 6.2 – Bathymetrical measurement using a weighted decametre on a transverse section of the River Vidourle.

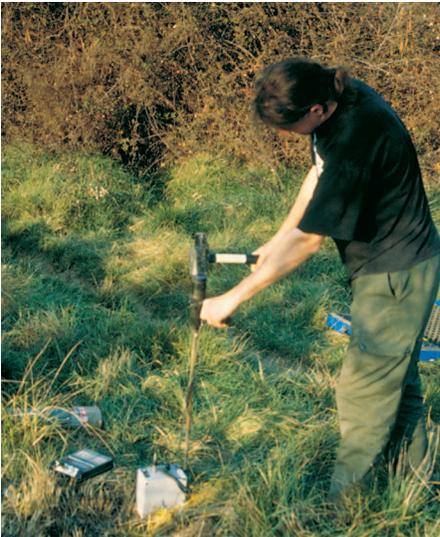
Photo 6.3 – Sounding using a PANDA lightweight dynamic penetrometer on the dikes of the Vidourle.

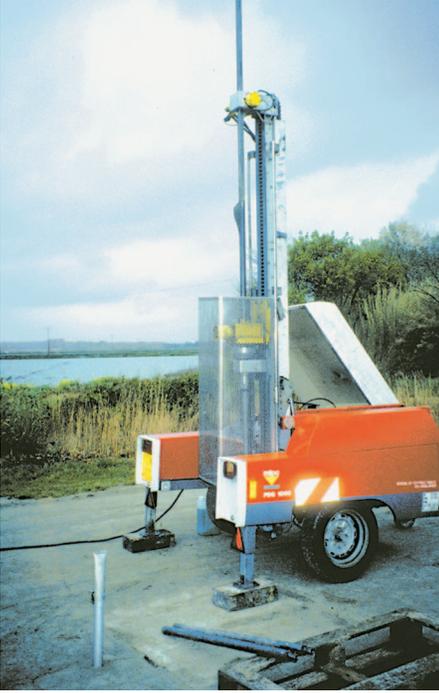
Photo 6.4 – A PDG 1000 dynamic penetrometer set up for sounding.

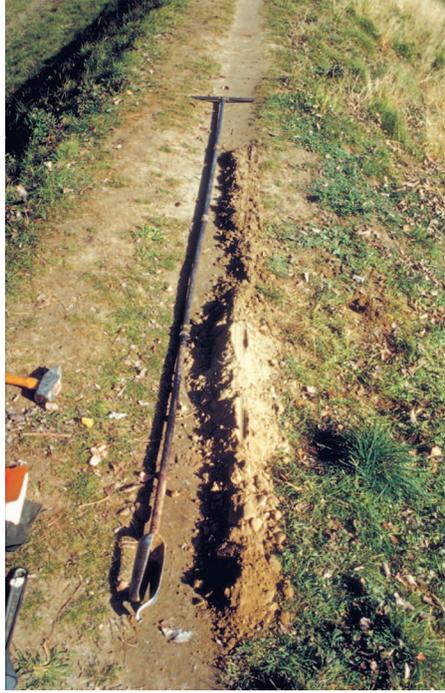
Photo 6.5 – Sounding with a manual earth auger in the sandy-silt body of a Camargue dike.

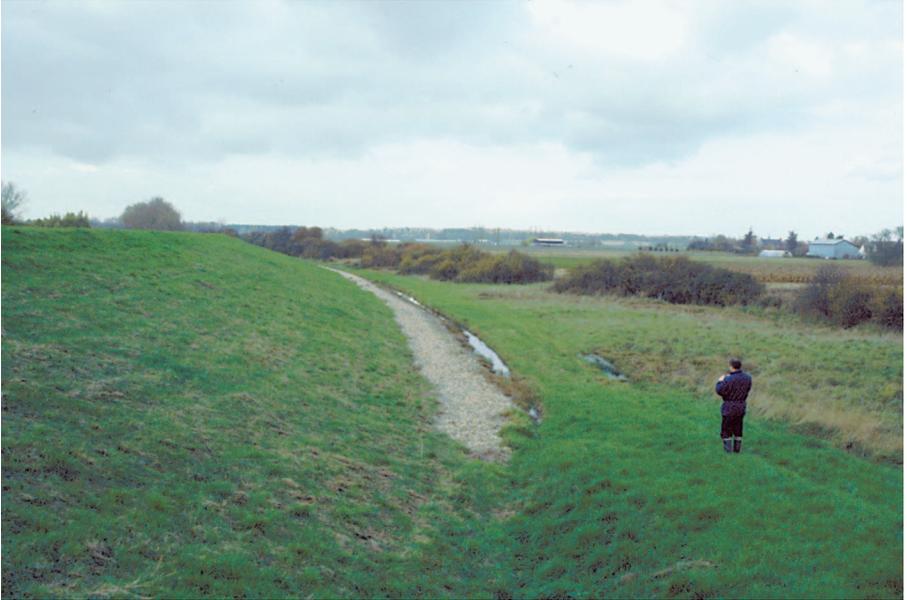
Photo 6.7 – Widening of the land-side slope over a drainage blanket – Val de Bou levee.

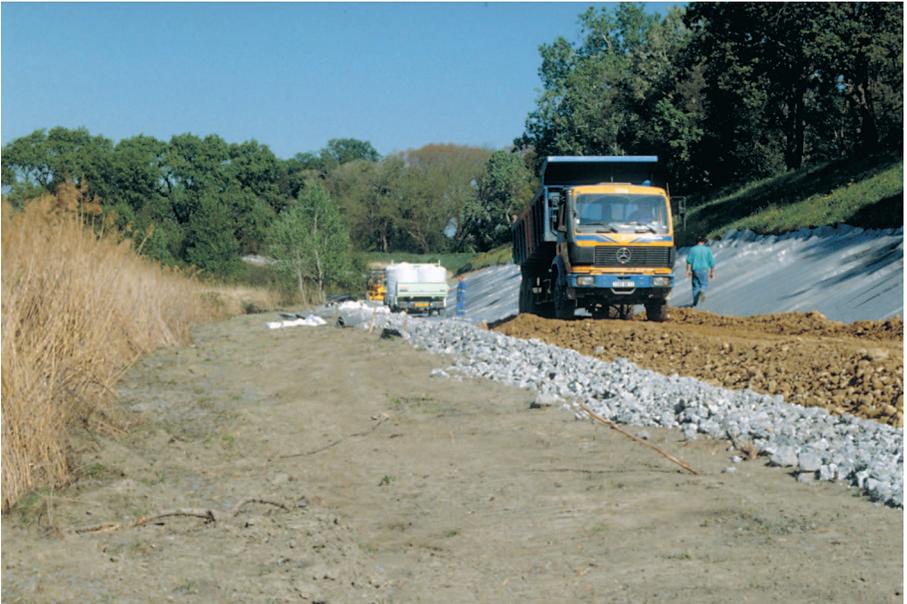
Photo 6.8 – Emergency construction of a downstream drainage shoulder at the toe of the land-side slope of the Petit Rhône dike following the flood of 8 January 1994.

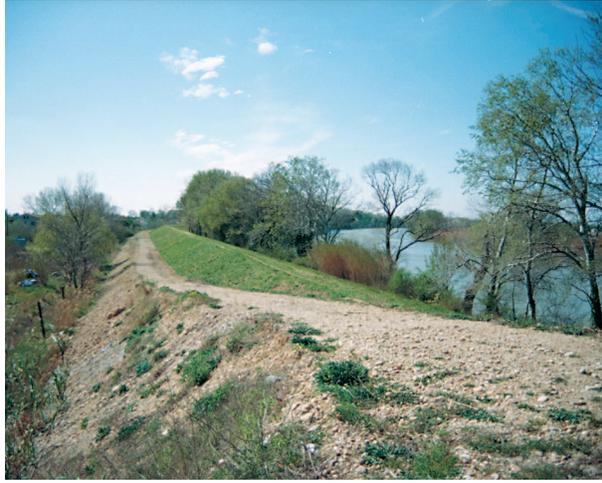
Photo 6.10 – Protection in the process of construction at the base of the river-side slope of the Val de Bou levee.

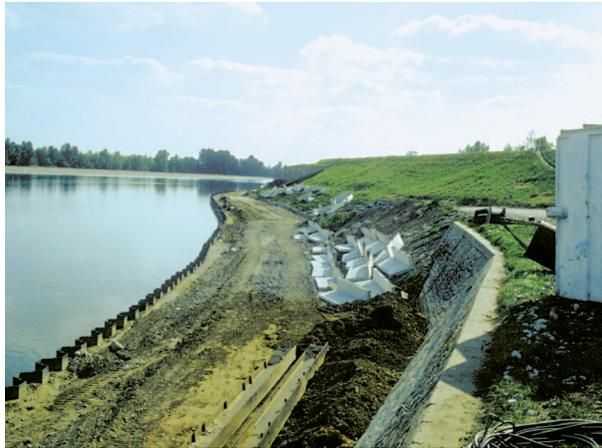
Photo 6.11 – Sheet piling as a protection for the base of the left-bank levee in St-Benoît (Loiret).

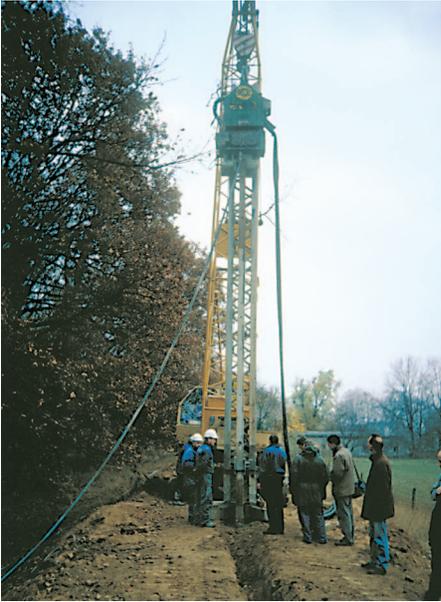
Photo 6.12 – Construction of a narrow diaphragm wall to create a seal in the body of a dike (Oder levee, Poland).

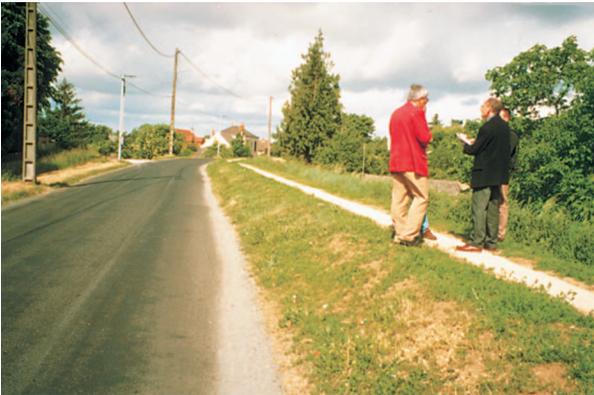
Photo 6.13 – River-side freeboard ridge and dike body strengthened with sheet piling on the Jargeau levee (Loiret).

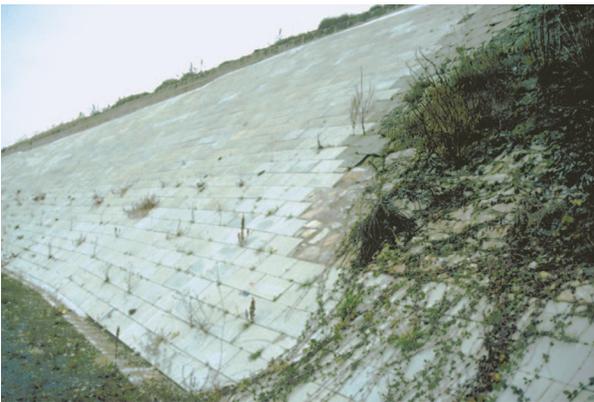
Photo 6.14 – River-side stone facing repaired with pre-fabricated elements on the Authion Valley levee.

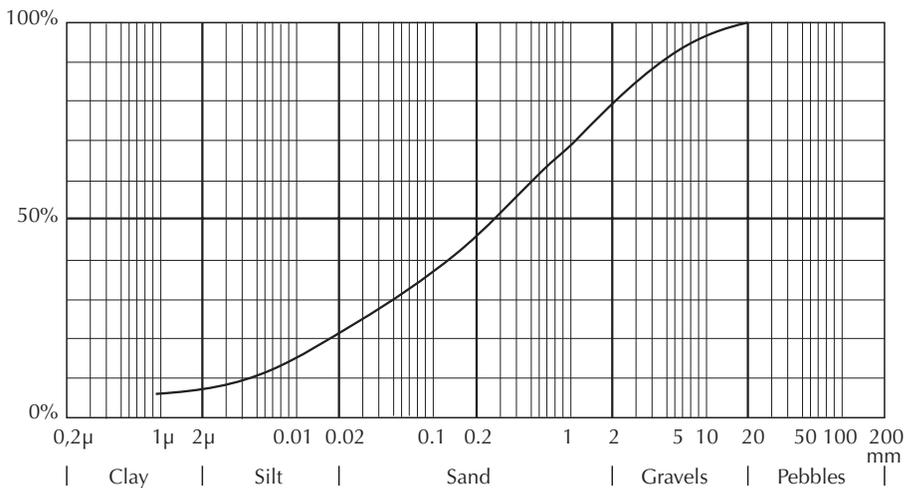
Figure 2. Granulometric curve

**The grain size graph** above shows the percentage, by weight, of grains that are smaller than the mesh diameter of the sieve. The graph is produced by sieving the soil to take out grains more than 80 μm in diameter. The sedimentometry test measures the proportion of the finest grains by decanting a soil suspension diluted in water.

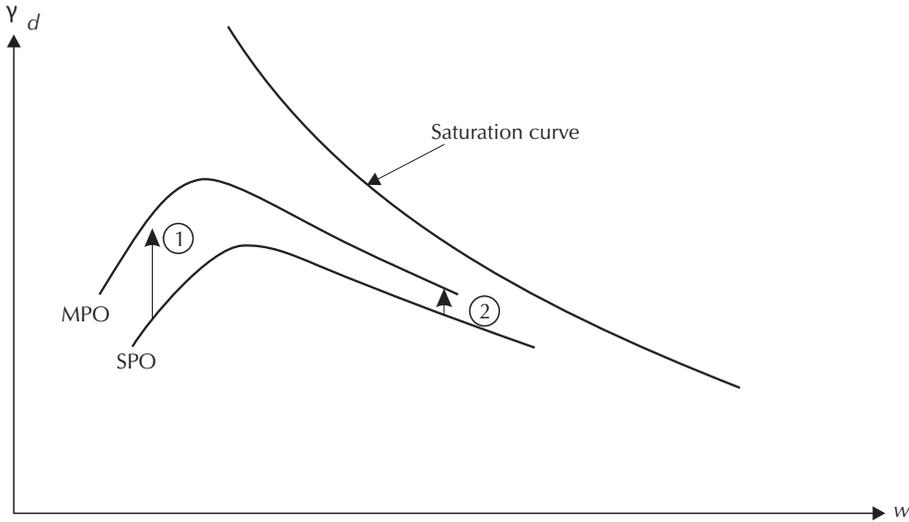
Figure 4. Proctor curves

On a compaction site, two quantities are controlled: water content and density, which must both lie within an acceptable range. For earthfills made from fine materials, the density value generally recommended is more than 98% of the optimum with a water content equal to the optimal water content + or - 1 or 2 percent (depending on the nature of the materials).

The Proctor curve is bounded by the so-called saturation curve. It represents the maximum density above which the material cannot be compacted any further (the limit curve for this soil condition).

Clearly, when water content is low, density can be increased by providing a greater compacting energy (1). However, when water content is high (> the optimal water content), there is little to be gained by increasing the energy (2). Worse still, some types of material react badly to over-compaction under these conditions and their density is reduced. Alternatively, saturated zones in the core of the fill will become the source of subsequent incidents.

The Proctor test generates a curve of dry weight by volume as a function of water content, for a given compaction energy. This test determines two quantities of fundamental importance to the operation and control of construction sites: the optimal water content ( $W_{op}$ ) and the optimal density ( $\gamma_{d_{op}}$ ).

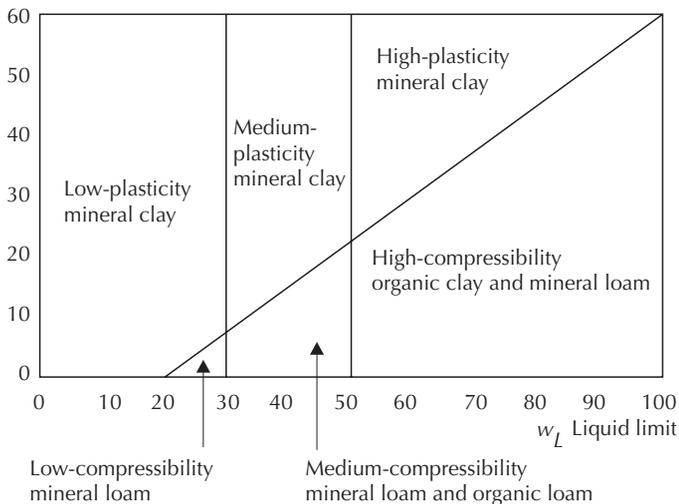
Figure 5. Casagrande plasticity nomograph

- The Casagrande diagram, which relates only to fine soils and uses Atterberg limits (Fig. 5).
- Taylor's triangular nomograph, which considers grain size only and is used to name a soil (clay, silt, sand, sandy clay loam, etc.) (Fig. 6).
- Standardised French classification NFP 11.300 September 1992 (Table 1), which replaces the former classification known as RTR (recommendations for earthworking for road applications) produced by the LCPC and SETRA, widely used in road geotechnology and which provides practical information about the ability of soils to be used as earthfill.

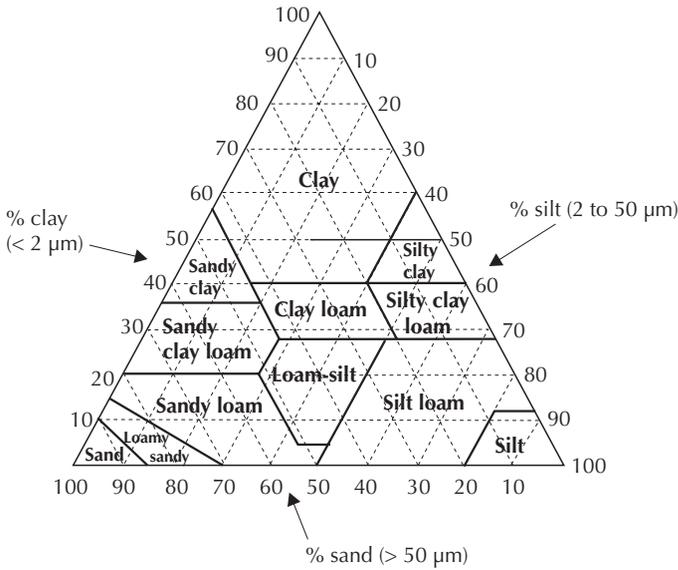
Figure 6. Triangular classification of fine soils

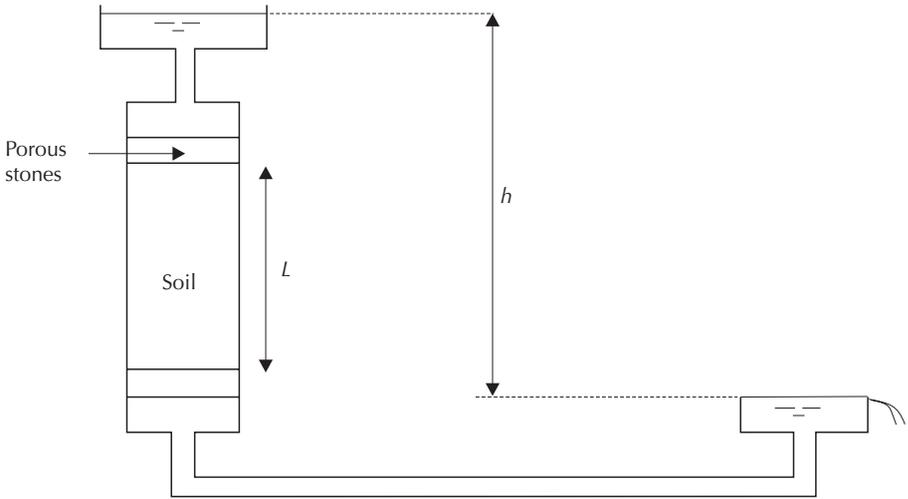
Figure 1. Principle of the permeameter: a soil sample subjected to a hydraulic gradient  $i = h/L$

- *In the laboratory*, the permeability is measured using a permeameter (the principle is illustrated in Fig. 1):

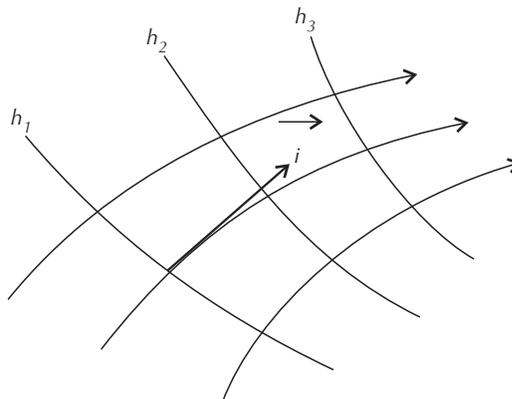
Equipotentials are lines along which the head  $h$  is constant. They are orthogonal to the flow lines.

Figure 2. Flow net of flow lines and equipotentials

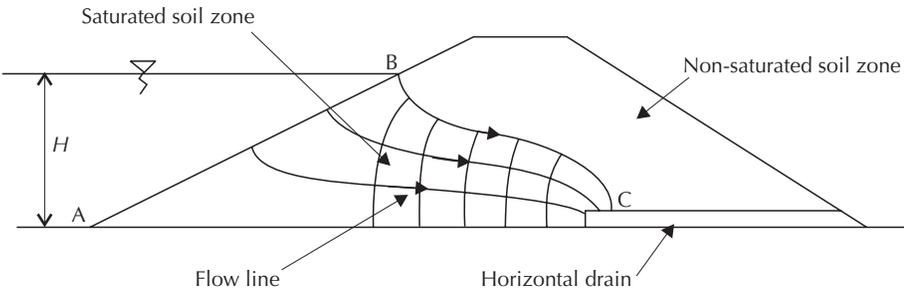
Consider a dam or dike that is drained horizontally, in a context of continuous flow. There are two boundary conditions in steady hydraulic state:  $h = H$  along the length of the dam face  $AB$  and  $h = z$  along  $BC$  (saturation curve).

The head is zero at the drain level. The saturation curve and the contact with the foundation are flow lines. Hence the appearance of the plot in Fig. 3.

Figure 3. Saturation of a hydraulic earthfill structure

For reasons of simplification, the example illustrates a horizontal drain in an isotropic medium. However, the practicalities of earthfill construction (using compacted layers) usually result in a high degree of anisotropy in the soil, with much higher permeabilities in the horizontal direction.

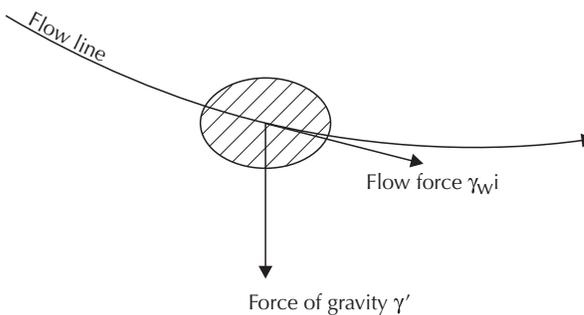
The force of gravity  $\gamma'$  applied to a grain of soil is proportional to its mass and acts in the vertical direction.

The flow force  $\gamma_w i$  acts tangentially to the flow line, and is proportional to the hydraulic gradient  $i$ .

Figure 4. Forces applied to a grain of soil

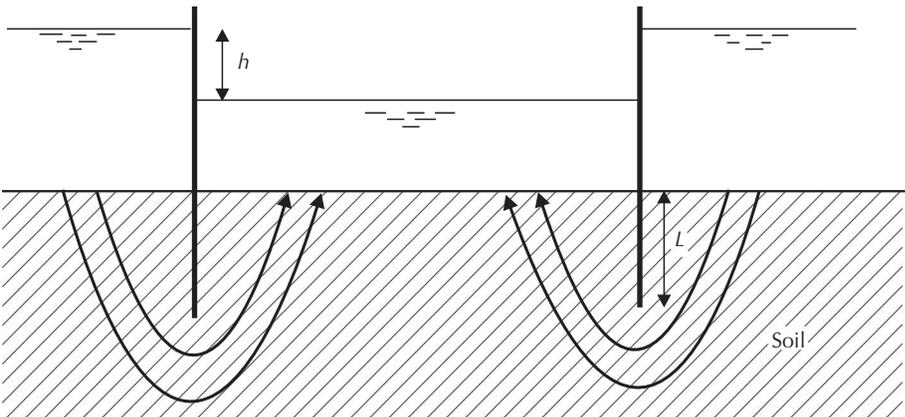
The critical gradient  $i_c$  is thus equal in this case to 1. In Figure 5 below,  $i = h / (2.L)$  and the piping appears when the drop in water level in the chamber reaches  $h = 2.L$ .

Figure 5. Flow under a chamber created from sheet piles

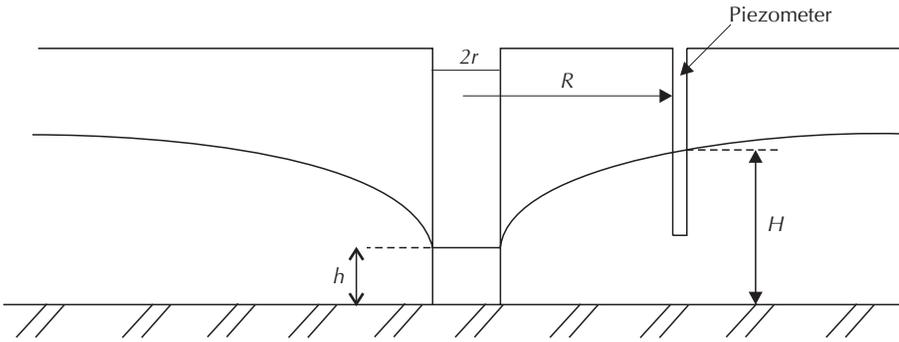
$$k = Q \frac{\ln(R/r)}{\pi(H^2 - h^2)}$$

with the heights  $h$  and  $H$  measured with respect to the impermeable substratum.

Figure 6. Groundwater drawdown

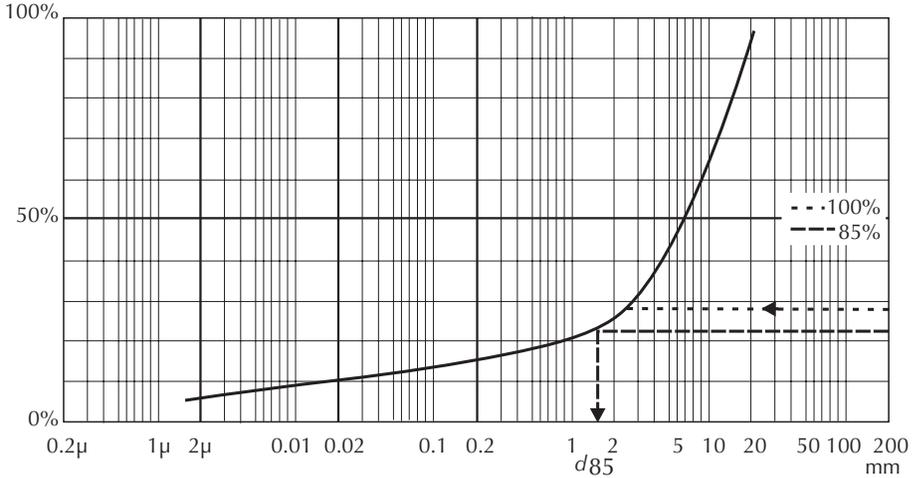
- The filter condition for the contact between two highly uniform materials ( $D_{60}/D_{10} < 3$  and  $d_{60}/d_{10} < 3$ ), – which is the case between the filter and drain – is written as:  $5d_{50} < D_{50} < 10d_{50}$ .
- Finally, a highly-graded soil ( $d_{60}/d_{10} > 16$ ) with a discontinuous grain size distribution is very likely to have its fine particles carried away by internal erosion due to the effect of flows of water. The filter abutting this material must therefore be determined using the  $d_{85}$  of the lower part of the granulometric curve for the soil, after the change in gradient of the curve (as shown in fig. 7).

Figure 7. Case of a soil with a discontinuous grain size distribution

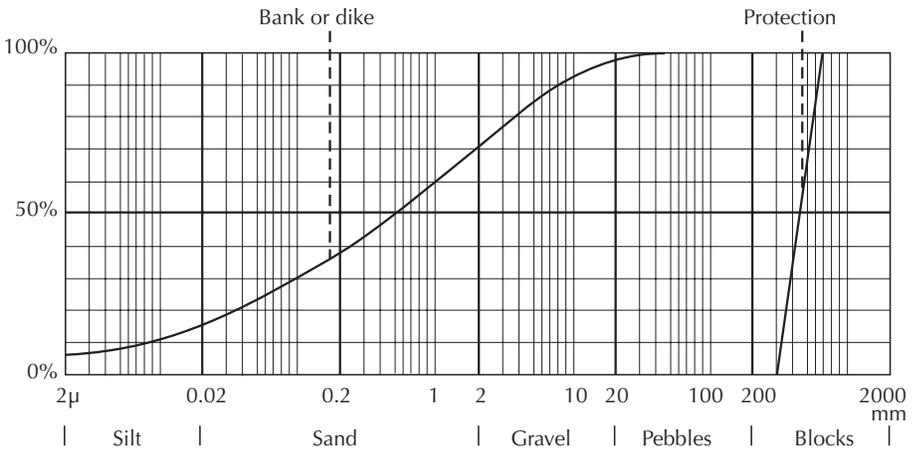
Consider a bank or a sandy dike, whose granulometric curve is shown below, and a protection against scouring provided by 300-700 mm blocks (i.e. weighing 50-400 kg).

A transition is required if  $0.2 \cdot d_{15} \text{ (protection)} > d_{85} \text{ (bank or dike)}$ .

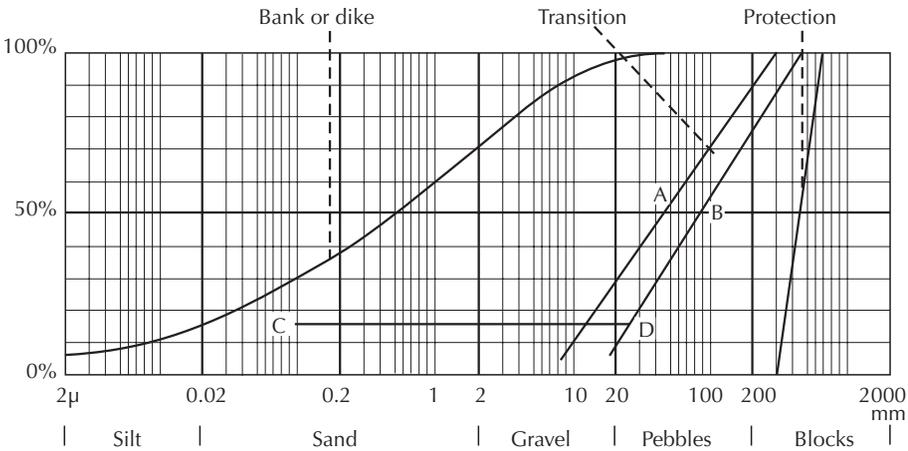
That is  $0.1 \text{ mm} < d_{15} \text{ (transition)} < 5 \times 5 = 25 \text{ mm}$  (CD segment).

The grading zone shown below is therefore appropriate since, moreover  $d_{60}/d_{10} = 6$  or 7 falls between 2 and 8.

**3.  $D_{15}$  condition for the transition**
